STC Test Report

No: HT195866

: One (1) group of submitted sample said to be
SHOWER HINGE
Style No.: BK009-135°
End Use: Bestko
Country of Destination: Global

Hinge Test

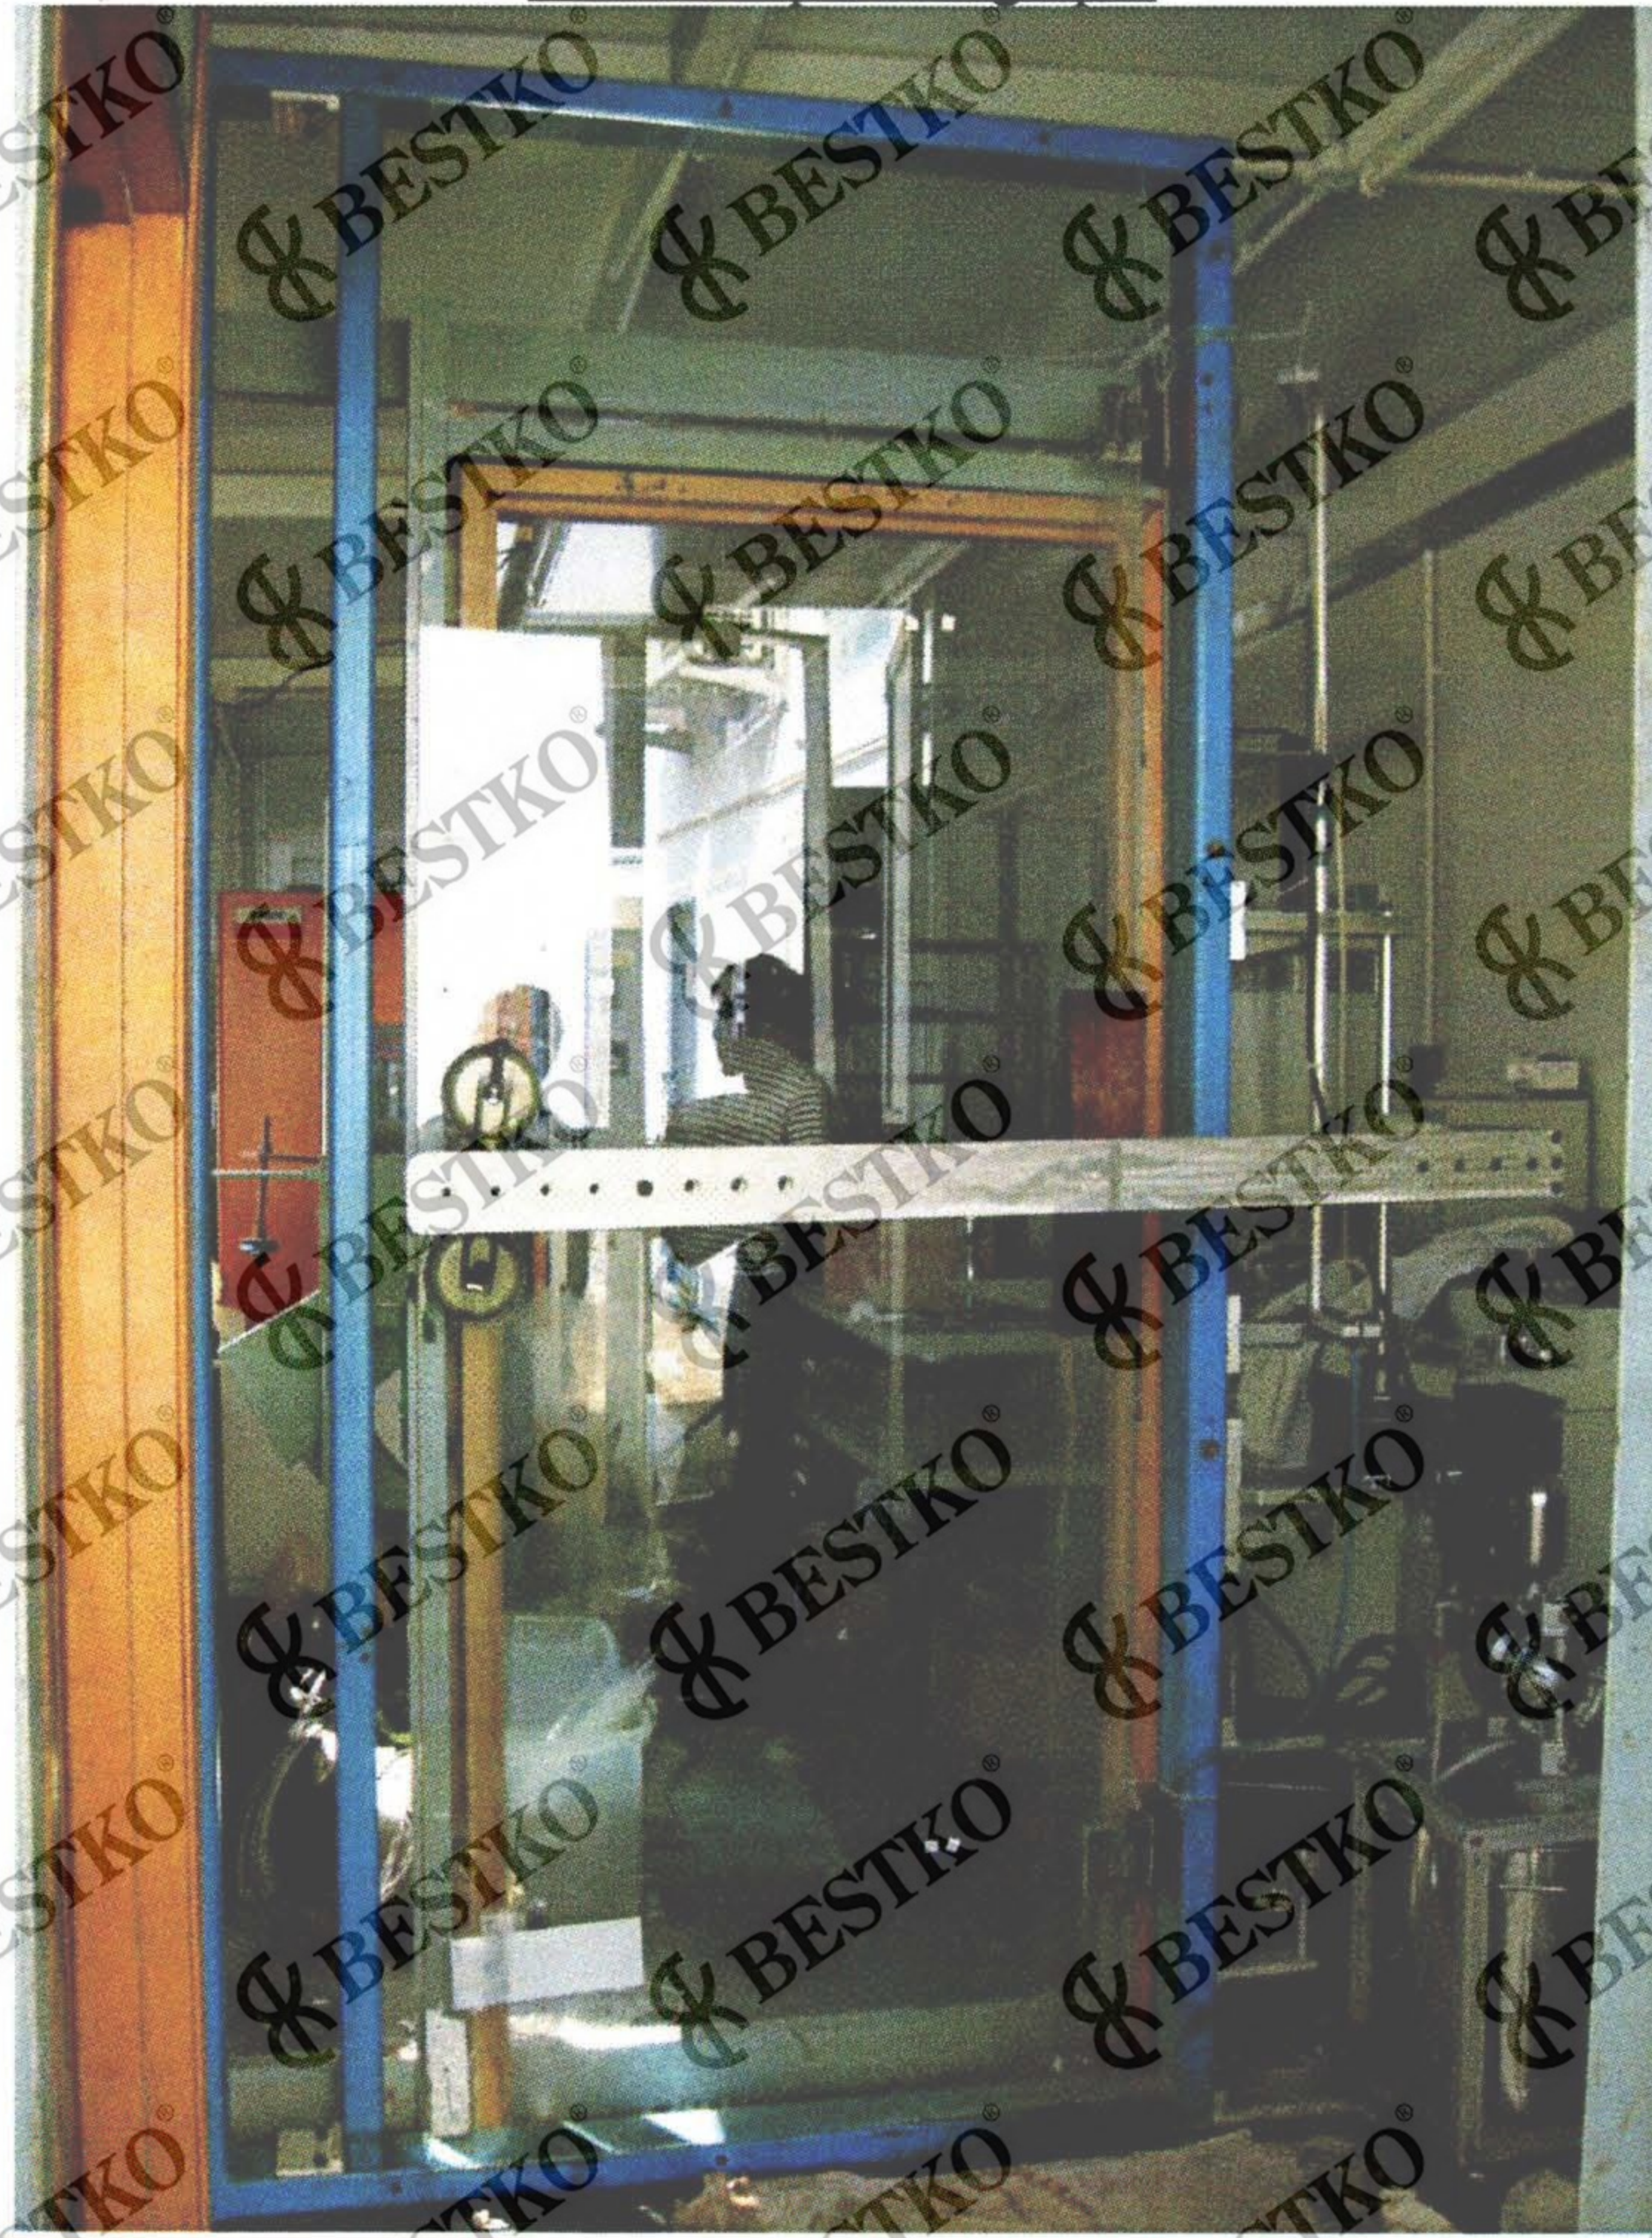
Test Set up Photograph:

1. The hinge with modified weight of 68kg tempered glass door were install in test frame that shall be constructed of 1/4 inch (6mm) wall, 2 inches (51mm) x 4 inches (102mm) steel tubing. The frame shall be no less than 36 inches (914 mm) wide and 96 inches (2438mm) in height. The corner shall be welded on the three exposed sides of a butt or mitered joint. Spacing between the vertical edges shall be plumbed to 1/8 inch (3mm) and spacing between the horizontal edges shall be plumbed to 3/16inch (5mm).

2. The tempered glass door was swing from 0° (closed) to 90° (open) and back to 0° every 10 seconds.
3. A mist of 80°F (+/- 3°F) tap water shall be directed onto one side of each hinge for 30 seconds every half-hour. Air temperature shall be maintained throughout the test at 72°F (+/- 3°F).

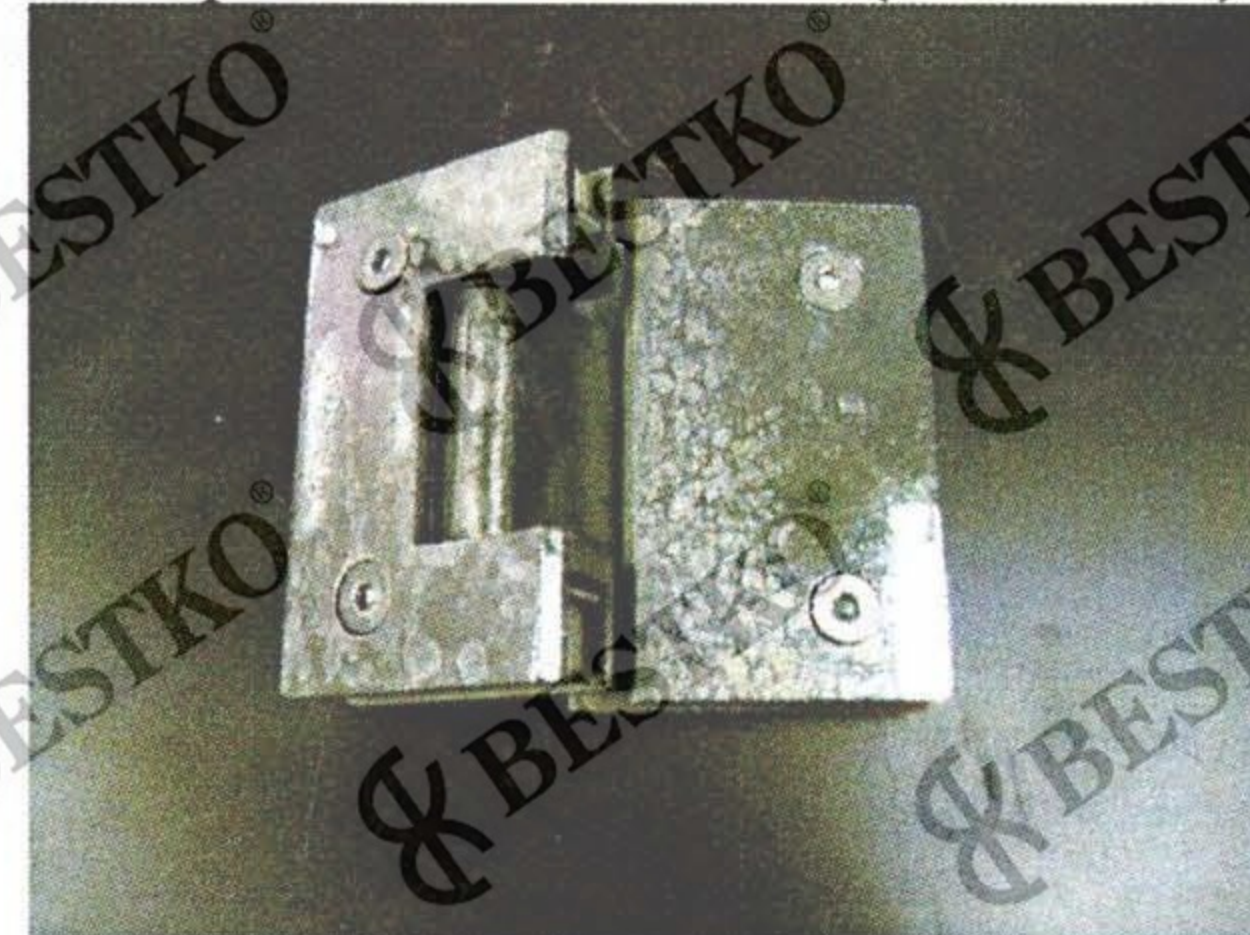
Sample: #BK009-135° (After test)

60,480	1) No noticeable degradation was observed on hinge. 2) Movement of vertical latch : 0mm		Pass
	69,120	1) No noticeable degradation was observed on hinge. 2) Movement of vertical latch : 0mm		Pass
	77,760	1) No noticeable degradation was observed on hinge. 2) Movement of vertical latch : 0mm		Pass
	80,000	1) No noticeable degradation was observed on hinge. 2) Movement of vertical latch : 0mm		Pass
