STC Test Report

No: HT195864

: One (1) group of submitted sample said to be
SHOWER HINGE
Style No.: BK958-180°
End Use: Bestko
Country of Destination: Global

Hinge Test

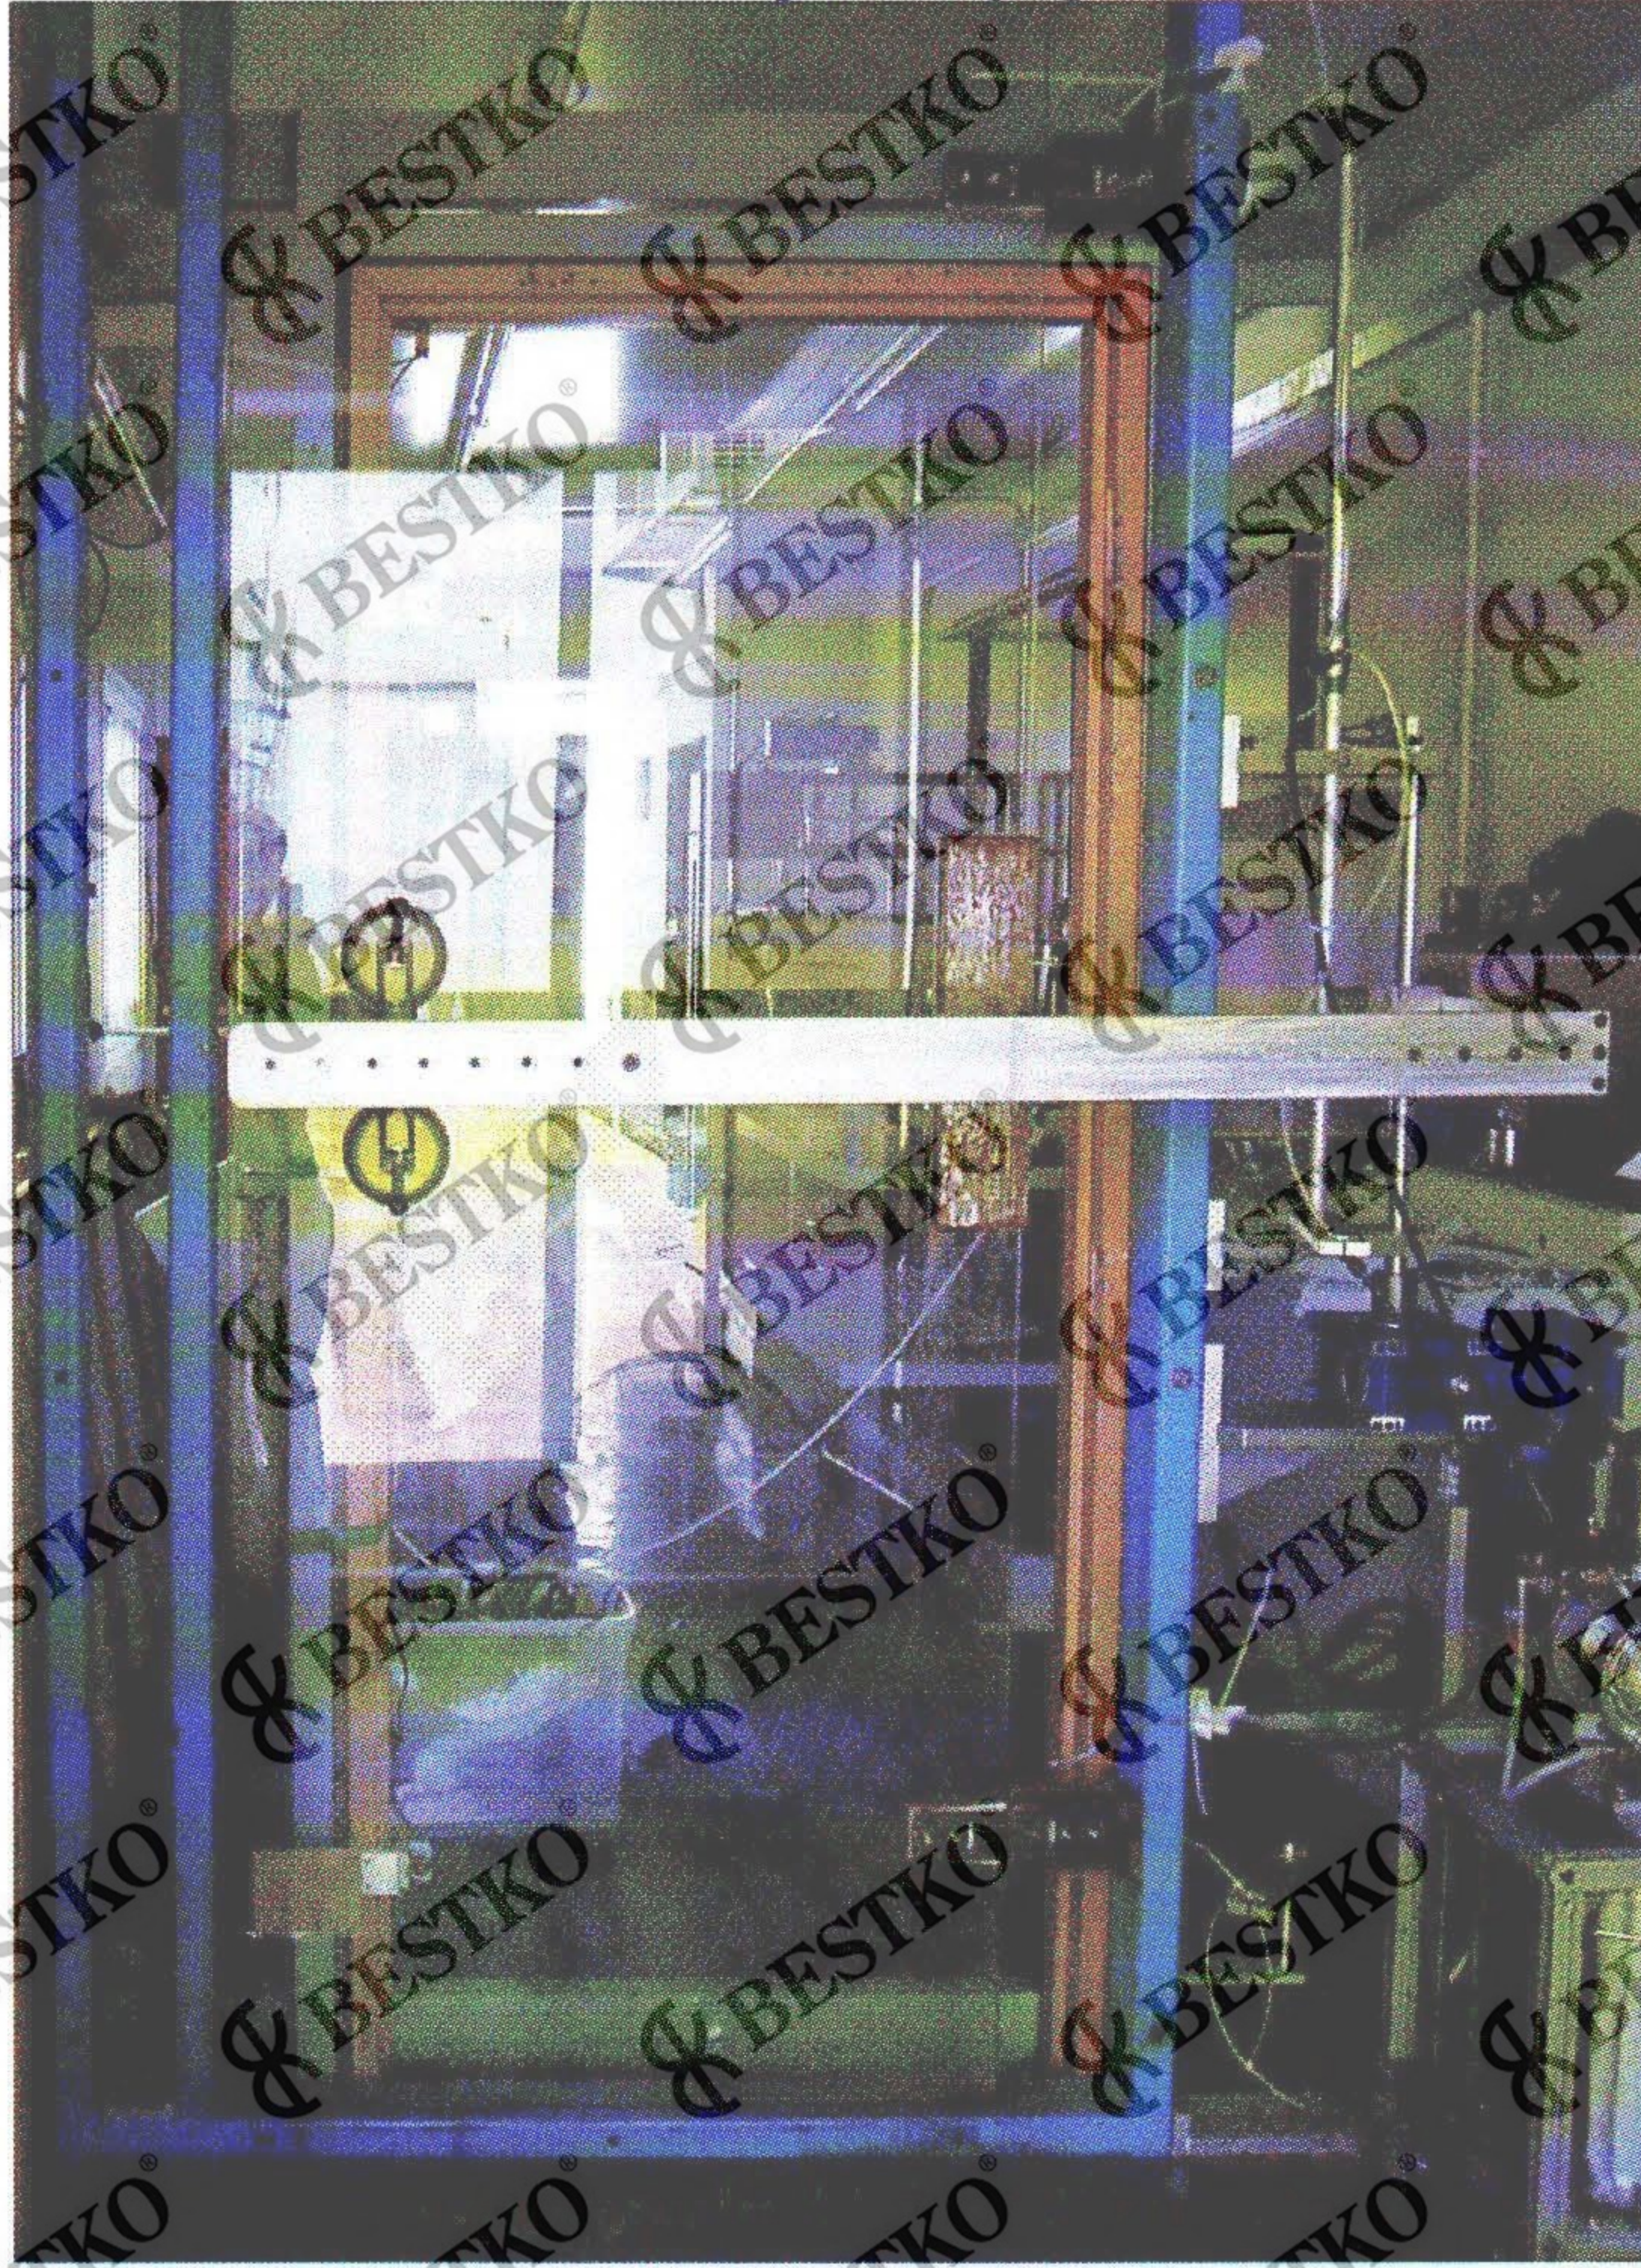
Test Set up Photograph:

1. The hinge with modified weight of 68kg tempered glass door were install in test frame that shall be constructed of 1/4 inch (6mm) wall, 2 inches (51mm) x 4 inches (102mm) steel tubing. The frame shall be no less than 36 inches (914 mm) wide and 96 inches (2438mm) in height. The corner shall be welded on the three exposed sides of a butt or mitered joint. Spacing between the vertical edges shall be plumbed to 1/8 inch (3mm) and spacing between the horizontal edges shall be plumbed to 3/16inch (5mm).

2. The tempered glass door was swing from 0° (closed) to 90° (open) and back to 0° every 10 seconds.
3. A mist of 80°F (+/- 3°F) tap water shall be directed onto one side of each hinge for 30 seconds every half-hour. Air temperature shall be maintained throughout the test at 72°F (+/- 3°F).

4. Inspect the hinges every 8,640 cycles and record the vertical latch spacing and any noticeable change in the hinge operation.

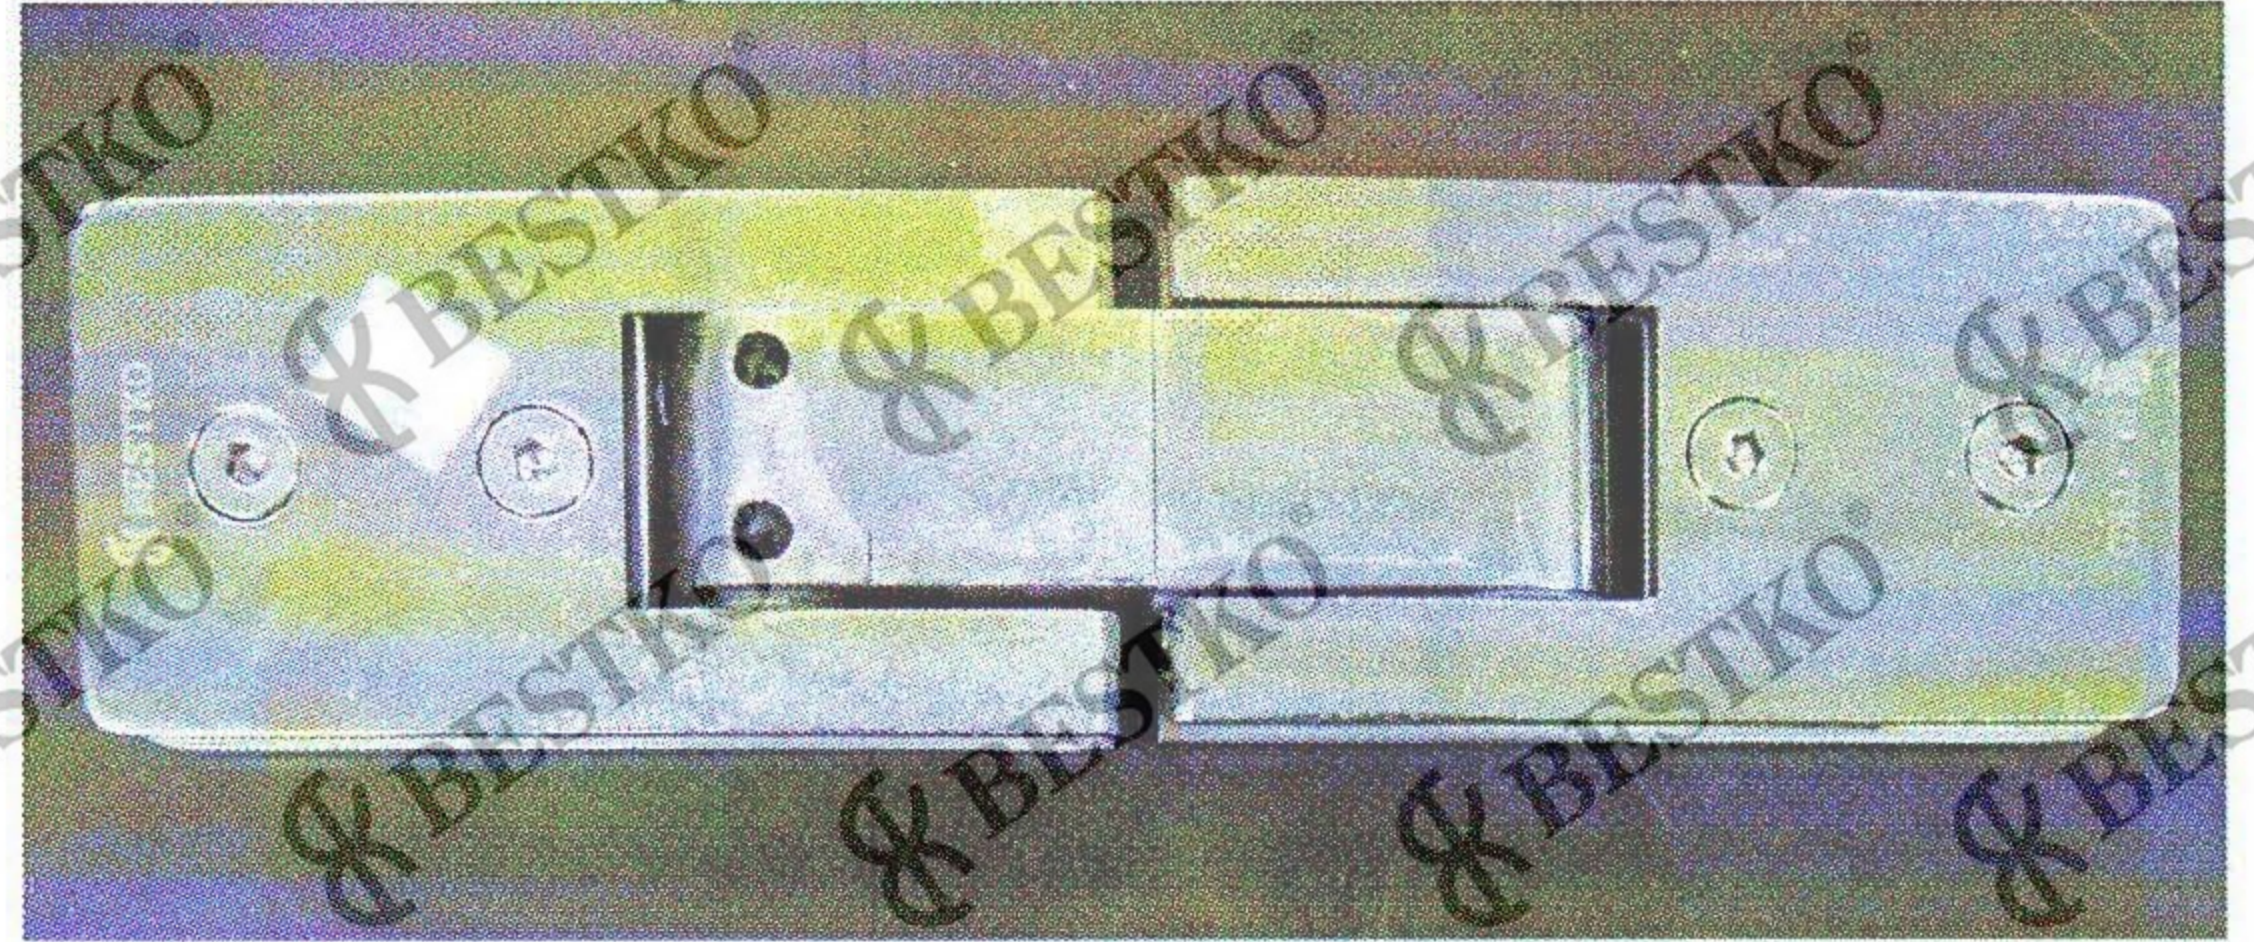
Sample: #BK958-180° (After test)

Sample	No. of cycle	Observation	Submitted requirement	Comment
#BK958-180°	8,640	1) No noticeable degradation was observed on hinge. 2) Movement of vertical latch : 0mm	1. If at any time during the test, noticeable degradation to the hinge becomes audible and/or visible through casual observation. 2. If slippage occurs, allowing movement of the vertical latch edge greater than 1/16 inch (2mm).	Pass
	17,280	1) No noticeable degradation was observed on hinge. 2) Movement of vertical latch : 0mm		Pass
	25,920	1) No noticeable degradation was observed on hinge. 2) Movement of vertical latch : 0mm		Pass
	34,560	1) No noticeable degradation was observed on hinge. 2) Movement of vertical latch : 0mm		Pass
	43,200	1) No noticeable degradation was observed on hinge. 2) Movement of vertical latch : 0mm		Pass
	51,840	1) No noticeable degradation was observed on hinge. 2) Movement of vertical latch : 0mm		Pass

60,480	1) No noticeable degradation was observed on hinge. 2) Movement of vertical latch : 0mm		Pass
	69,120	1) No noticeable degradation was observed on hinge. 2) Movement of vertical latch : 0mm		Pass
	77,760	1) No noticeable degradation was observed on hinge. 2) Movement of vertical latch : 0mm		Pass
	80,000	1) No noticeable degradation was observed on hinge. 2) Movement of vertical latch : 0mm		Pass
