STC Test Report

No: HT195869

: One (1) group of submitted sample said to be
SHOWER HINGE
Style No.: BK960-135°
End Use: Bestko
Country of Destination: Global

Hinge Test

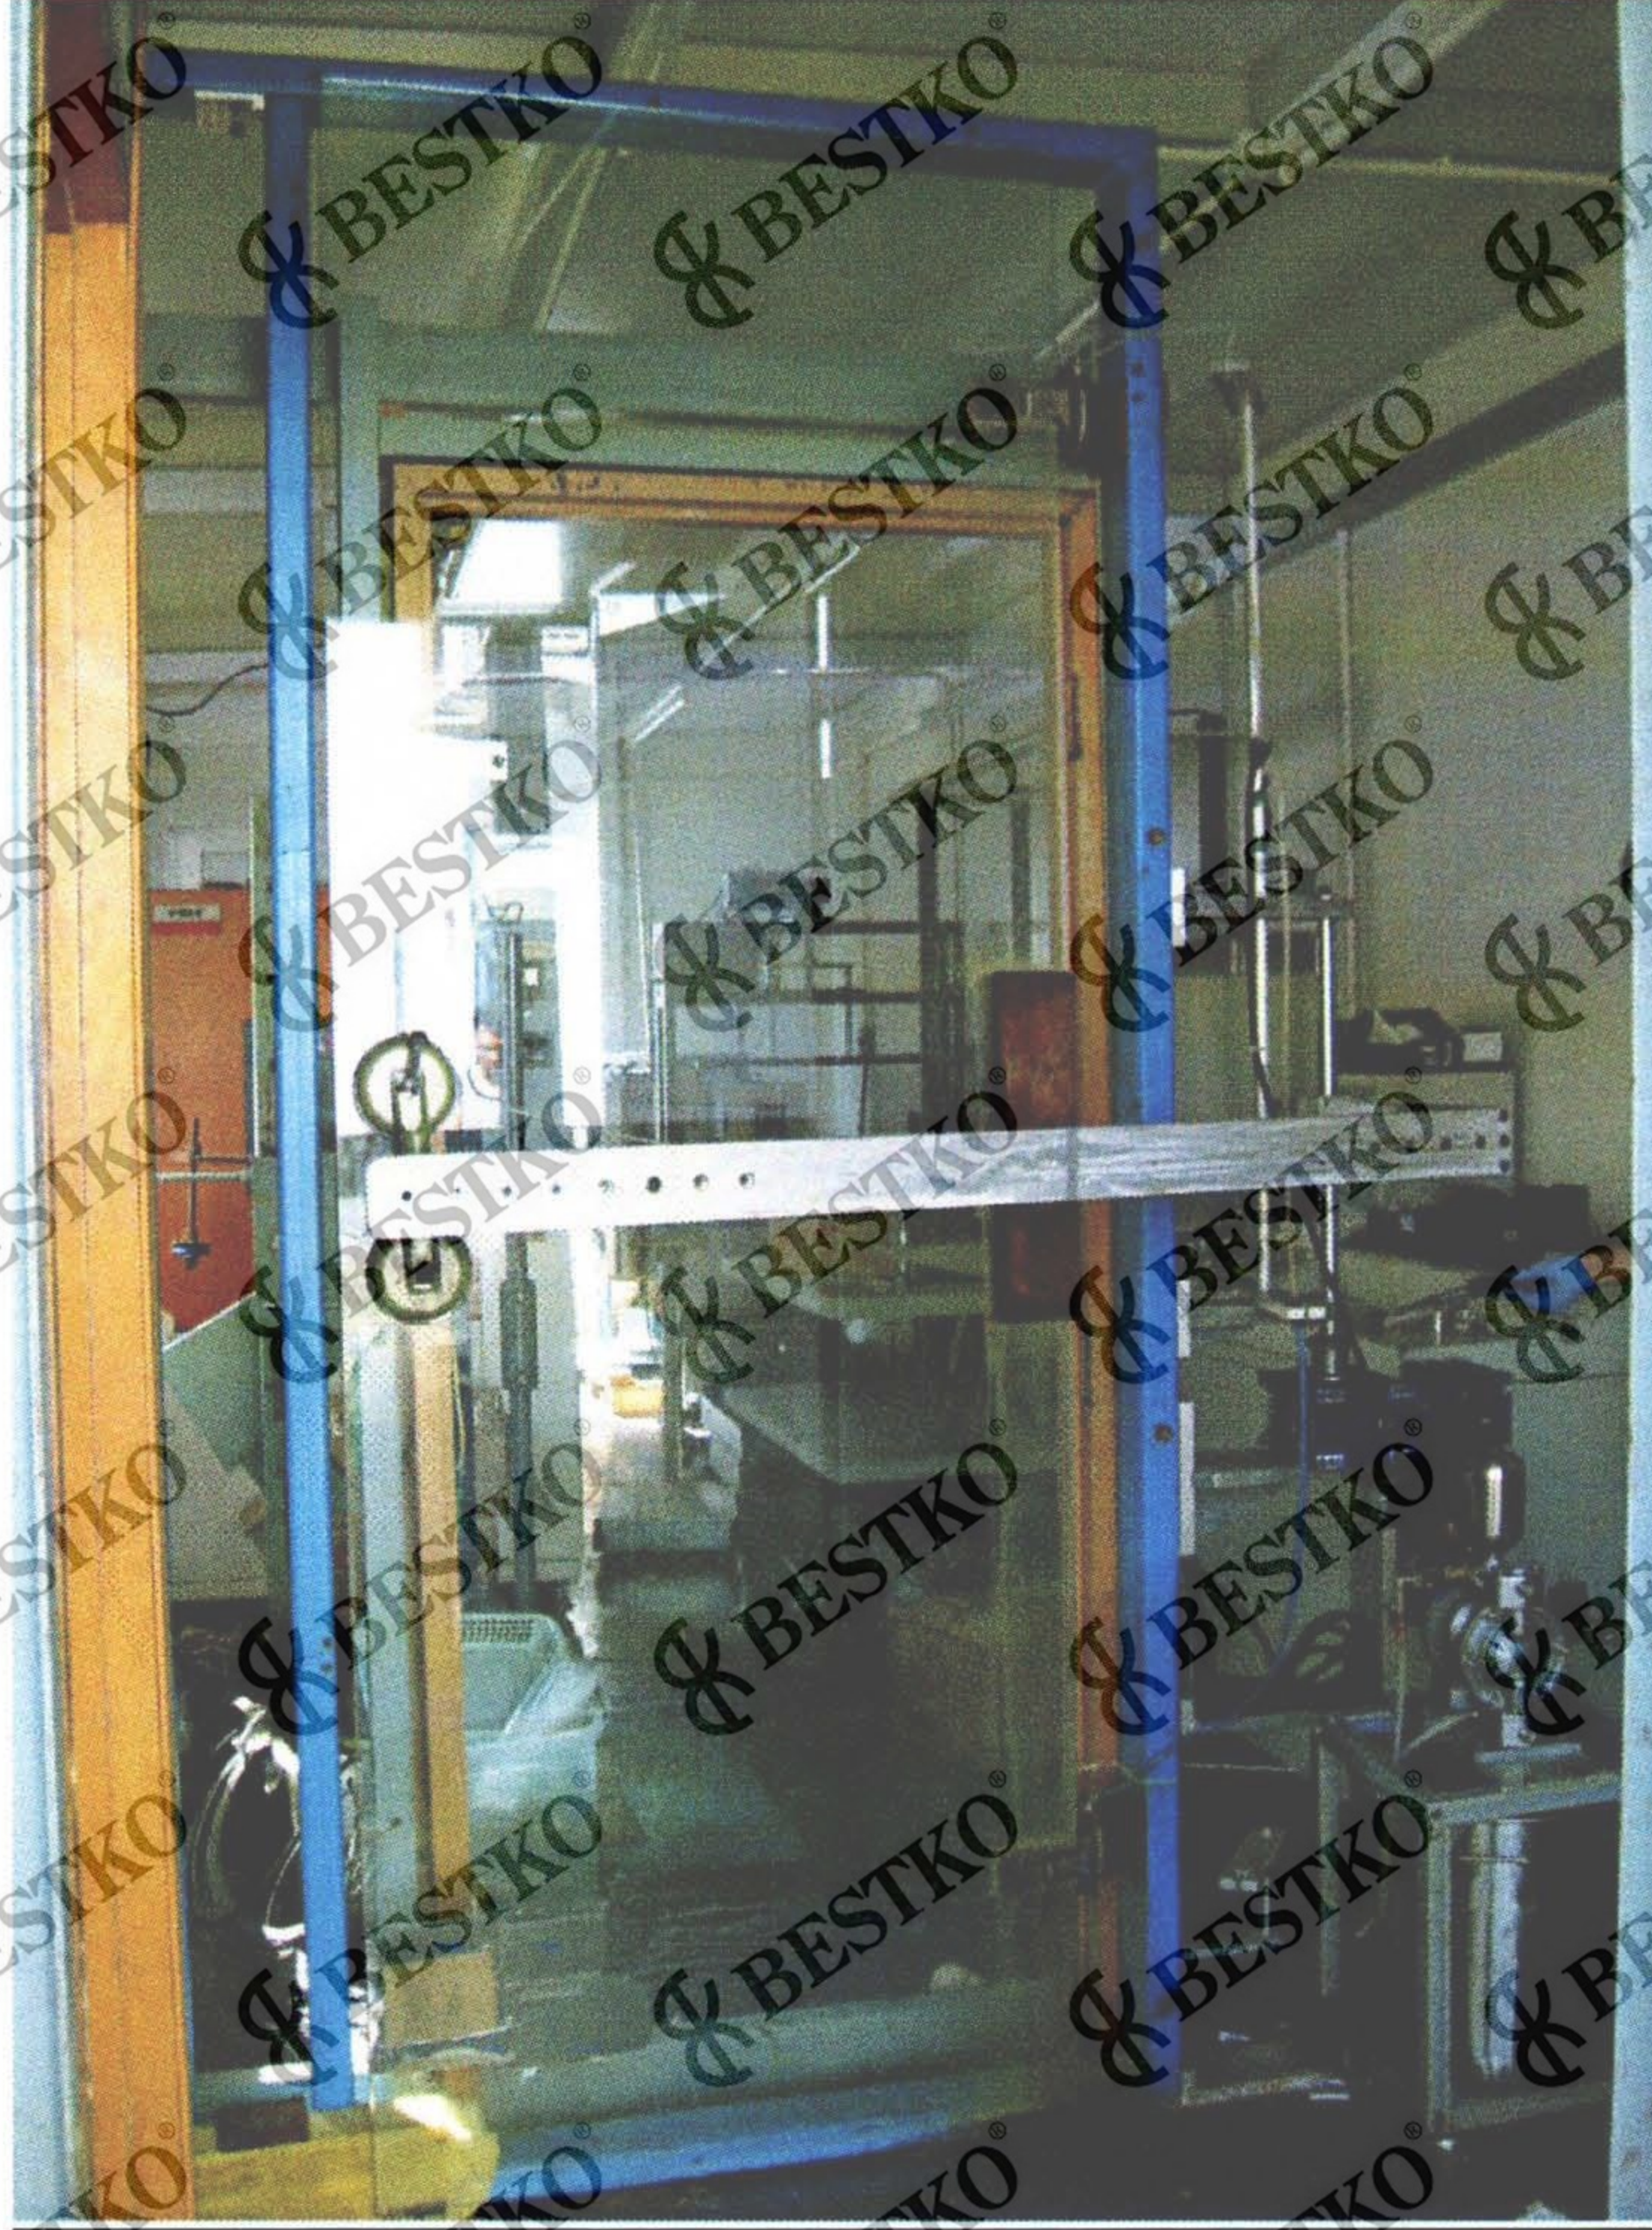
Test Set up Photograph:

1. The hinge with modified weight of 68kg tempered glass door were install in test frame that shall be constructed of 1/4 inch (6mm) wall, 2 inches (51mm) x 4 inches (102mm) steel tubing. The frame shall be no less than 36 inches (914 mm) wide and 96 inches (2438mm) in height. The corner shall be welded on the three exposed sides of a butt or mitered joint. Spacing between the vertical edges shall be plumbed to 1/8 inch (3mm) and spacing between the horizontal edges shall be plumbed to 3/16inch (5mm).

2. The tempered glass door was swing from 0° (closed) to 90° (open) and back to 0° every 10 seconds.
3. A mist of 80°F (+/- 3°F) tap water shall be directed onto one side of each hinge for 30 seconds every half-hour. Air temperature shall be maintained throughout the test at 72°F (+/- 3°F).

4. Inspect the hinges every 8,640 cycles and record the vertical latch spacing and any noticeable change in the hinge operation.

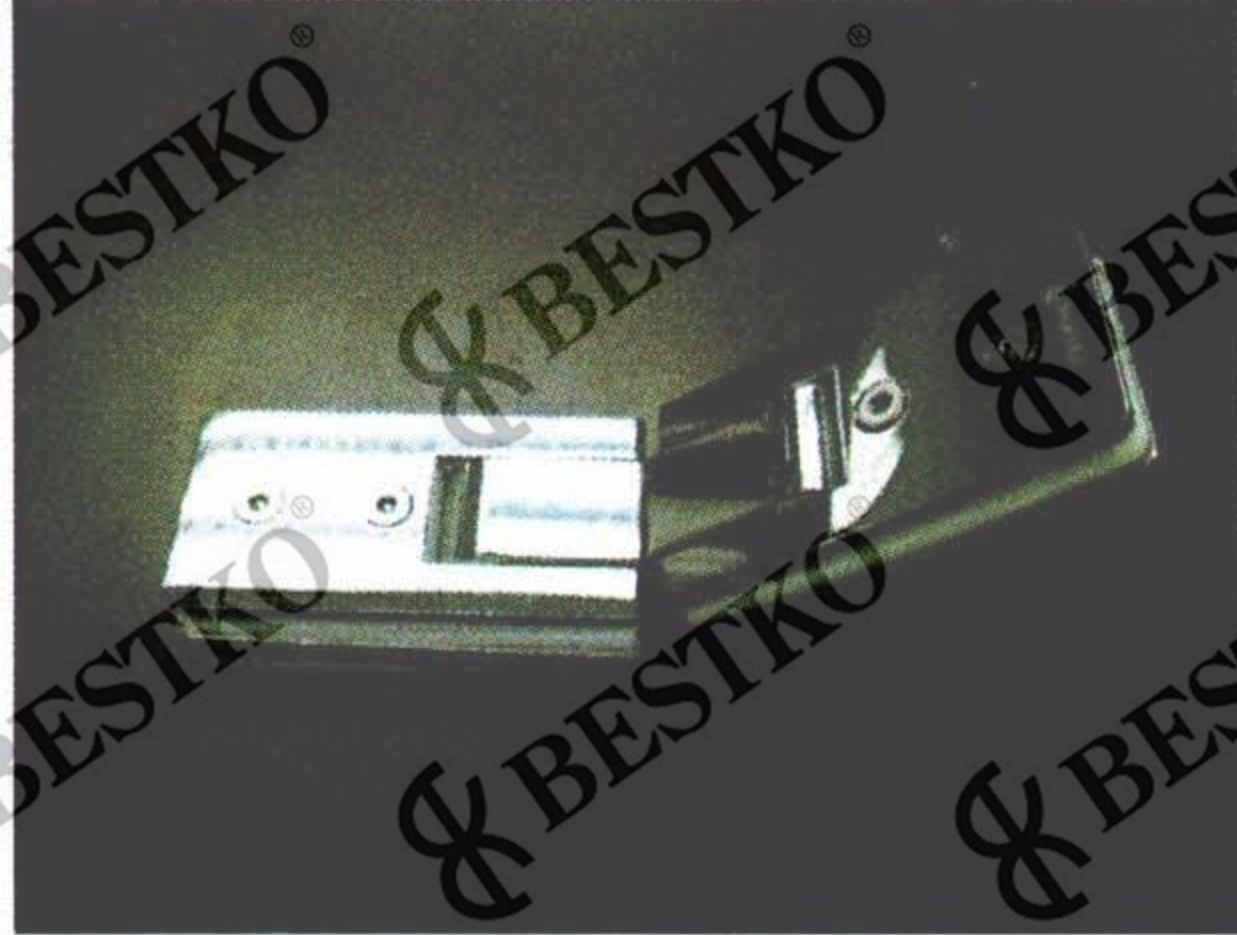
Sample: #BK960-135° (Before test)

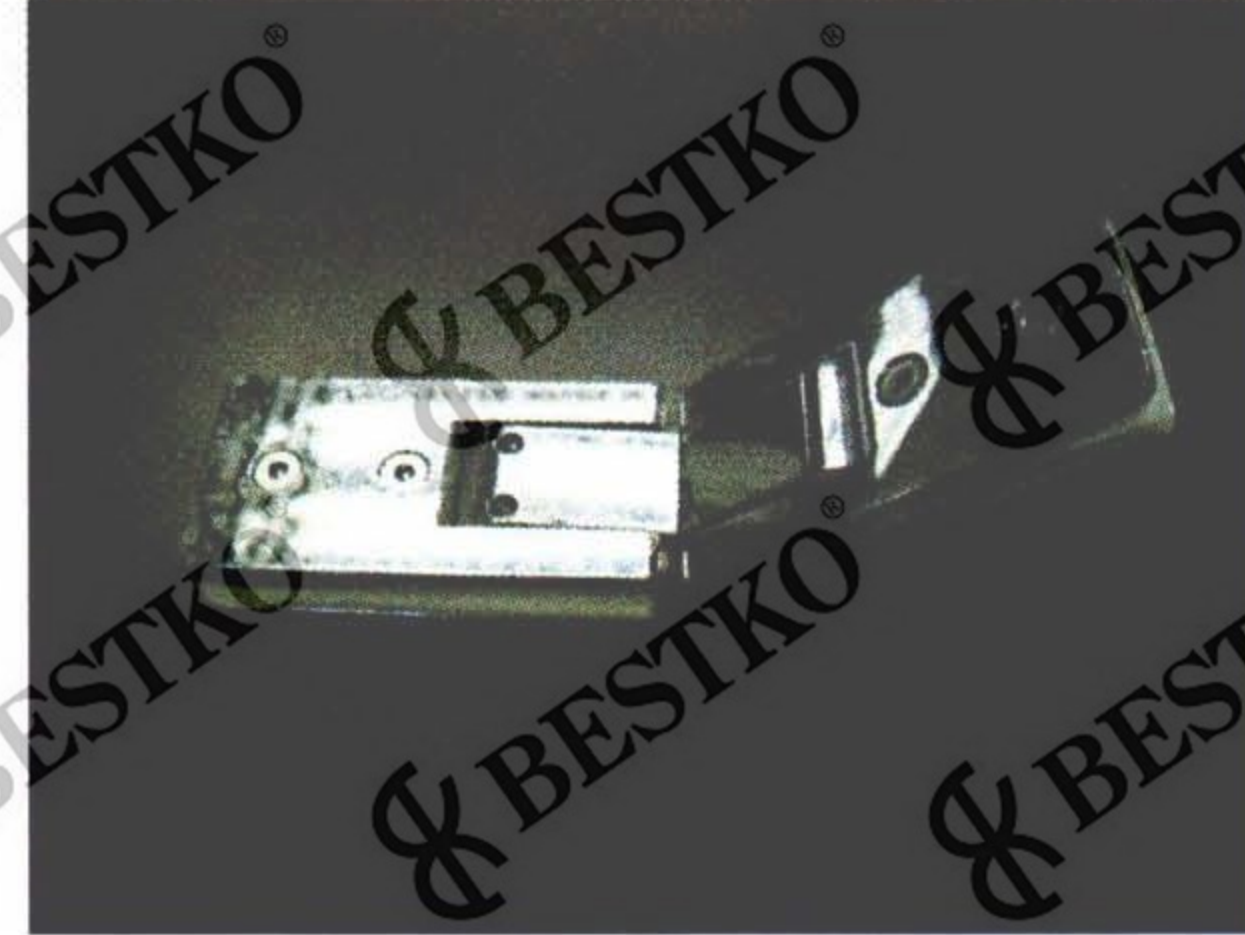
Sample: #BK960-135° (After test)

Sample	No. of cycle	Observation	Submitted requirement	Comment
#BK960-135°	8,640	1) No noticeable degradation was observed on hinge. 2) Movement of vertical latch : 0mm	1. If at any time during the test, noticeable degradation to the hinge becomes audible and/or visible through casual observation. 2. If slippage occurs, allowing movement of the vertical latch edge greater than 1/16 inch (2mm).	Pass
	17,280	1) No noticeable degradation was observed on hinge. 2) Movement of vertical latch : 0mm		Pass
	25,920	1) No noticeable degradation was observed on hinge. 2) Movement of vertical latch : 0mm		Pass
	34,560	1) No noticeable degradation was observed on hinge. 2) Movement of vertical latch : 0mm		Pass
	43,200	1) No noticeable degradation was observed on hinge. 2) Movement of vertical latch : 0mm		Pass
	51,840	1) No noticeable degradation was observed on hinge. 2) Movement of vertical latch : 0mm		Pass

60,480	1) No noticeable degradation was observed on hinge. 2) Movement of vertical latch : 0mm		Pass
	69,120	1) No noticeable degradation was observed on hinge. 2) Movement of vertical latch : 0mm		Pass
	77,760	1) No noticeable degradation was observed on hinge. 2) Movement of vertical latch : 0mm		Pass
	80,000	1) No noticeable degradation was observed on hinge. 2) Movement of vertical latch : 0mm		Pass
