## STC Test Report

No: HT195868

: One (1) group of submitted sample said to be  
SHOWER HINGE  
Style No.: BK935B-90°  
End Use: Bestko  
Country of Destination: Global

### Hinge Test

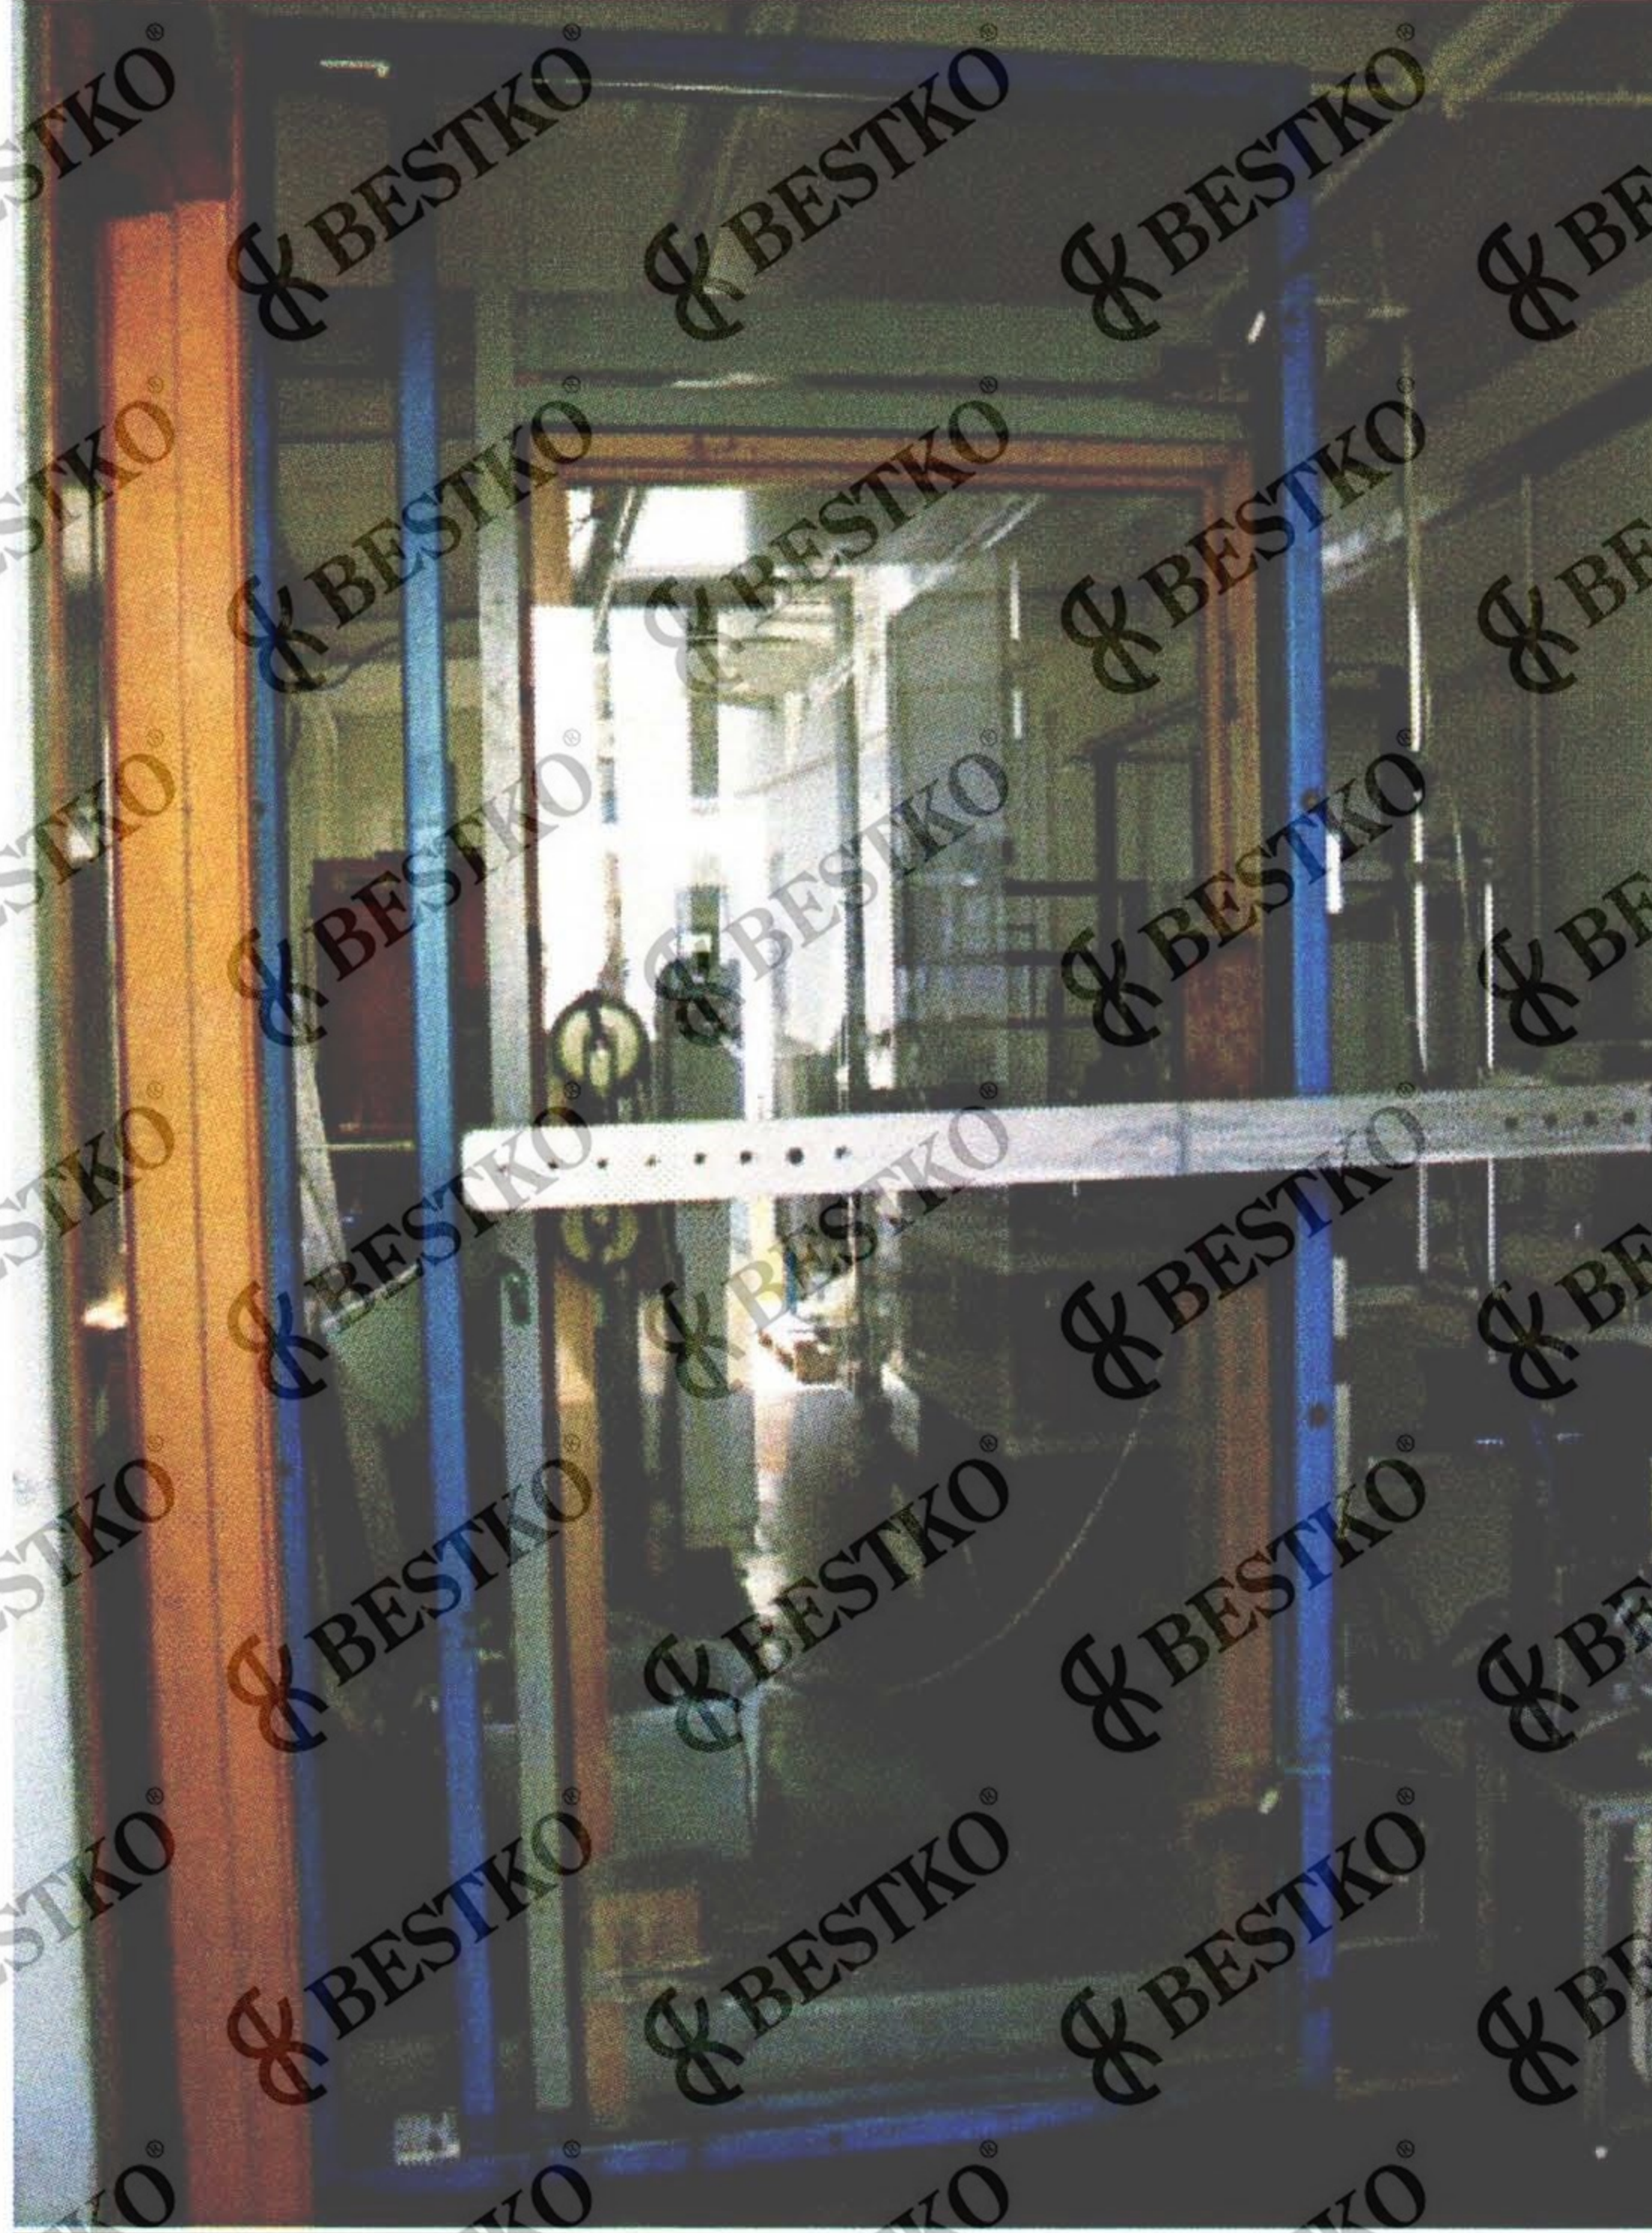
Test Set up Photograph:

1. The hinge with modified weight of 68kg tempered glass door were install in test frame that shall be constructed of 1/4 inch (6mm) wall, 2 inches (51mm) x 4 inches (102mm) steel tubing. The frame shall be no less than 36 inches (914 mm) wide and 96 inches (2438mm) in height. The corner shall be welded on the three exposed sides of a butt or mitered joint. Spacing between the vertical edges shall be plumbed to 1/8 inch (3mm) and spacing between the horizontal edges shall be plumbed to 3/16inch (5mm).

2. The tempered glass door was swing from 0° (closed) to 90° (open) and back to 0° every 10 seconds.
3. A mist of 80°F (+/- 3°F) tap water shall be directed onto one side of each hinge for 30 seconds every half-hour. Air temperature shall be maintained throughout the test at 72°F (+/- 3°F).

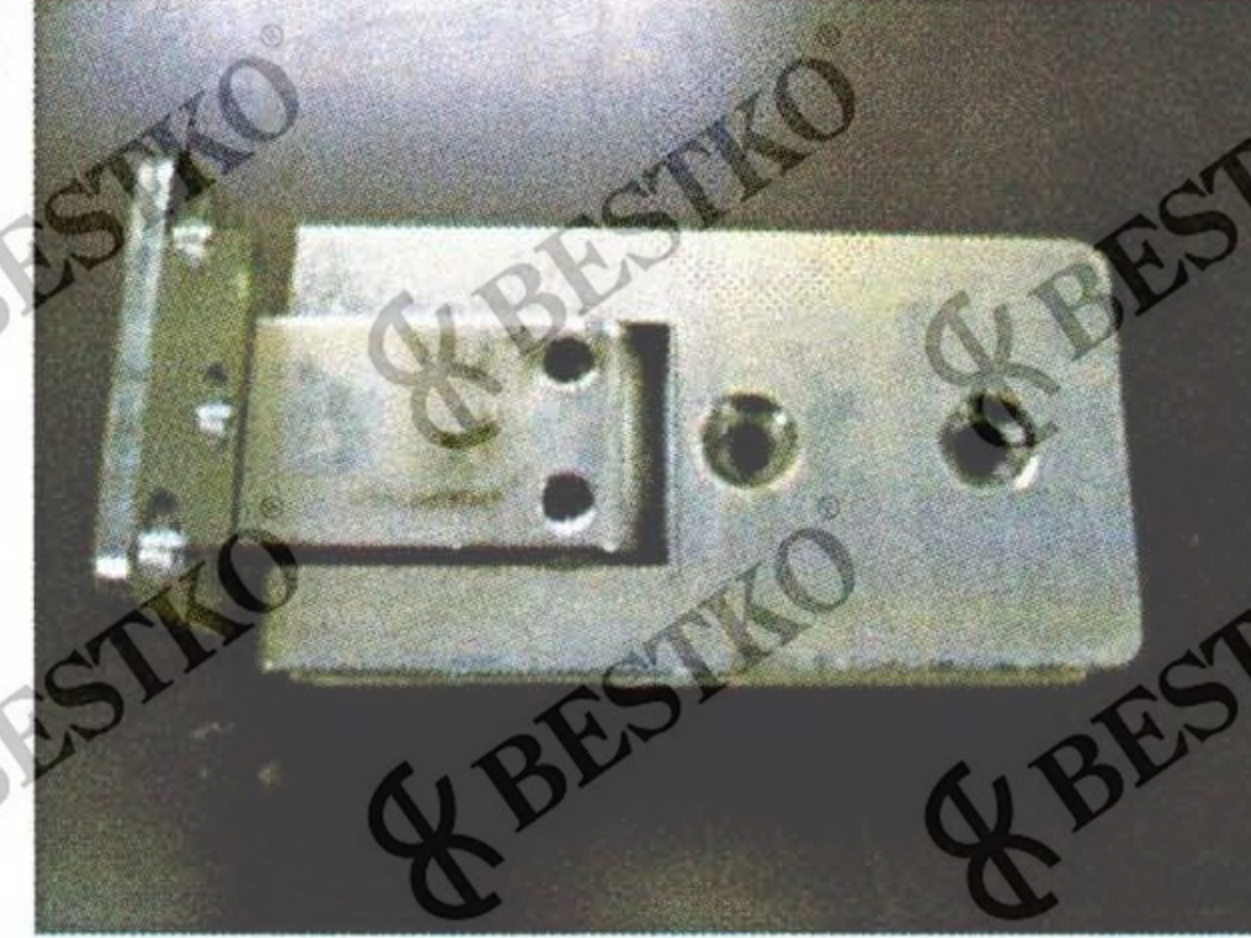
Sample: #BK935B-90° (After test)

Sample	No. of cycle	Observation	Submitted requirement	Comment
#BK935B-90°	8,640	1) No noticeable degradation was observed on hinge. 2) Movement of vertical latch : 0mm	1. If at any time during the test, noticeable degradation to the hinge becomes audible and/or visible through casual observation. 2. If slippage occurs, allowing movement of the vertical latch edge greater than 1/16 inch (2mm).	Pass
	17,280	1) No noticeable degradation was observed on hinge. 2) Movement of vertical latch : 0mm		Pass
	25,920	1) No noticeable degradation was observed on hinge. 2) Movement of vertical latch : 0mm		Pass
	34,560	1) No noticeable degradation was observed on hinge. 2) Movement of vertical latch : 0mm		Pass
	43,200	1) No noticeable degradation was observed on hinge. 2) Movement of vertical latch : 0mm		Pass
	51,840	1) No noticeable degradation was observed on hinge. 2) Movement of vertical latch : 0mm		Pass

60,480	1) No noticeable degradation was observed on hinge. 2) Movement of vertical latch : 0mm		Pass
	69,120	1) No noticeable degradation was observed on hinge. 2) Movement of vertical latch : 0mm		Pass
	77,760	1) No noticeable degradation was observed on hinge. 2) Movement of vertical latch : 0mm		Pass
	80,000	1) No noticeable degradation was observed on hinge. 2) Movement of vertical latch : 0mm		Pass
