## STC Test Report

No: HT207784

**Description of Sample(s)** : Five (5) pairs of submitted sample said to be  
HYDRAULIC SHOWER HINGE  
Style No.: TJ012-90°  
End Use: Bestko  
Country of Destination: Worldwide

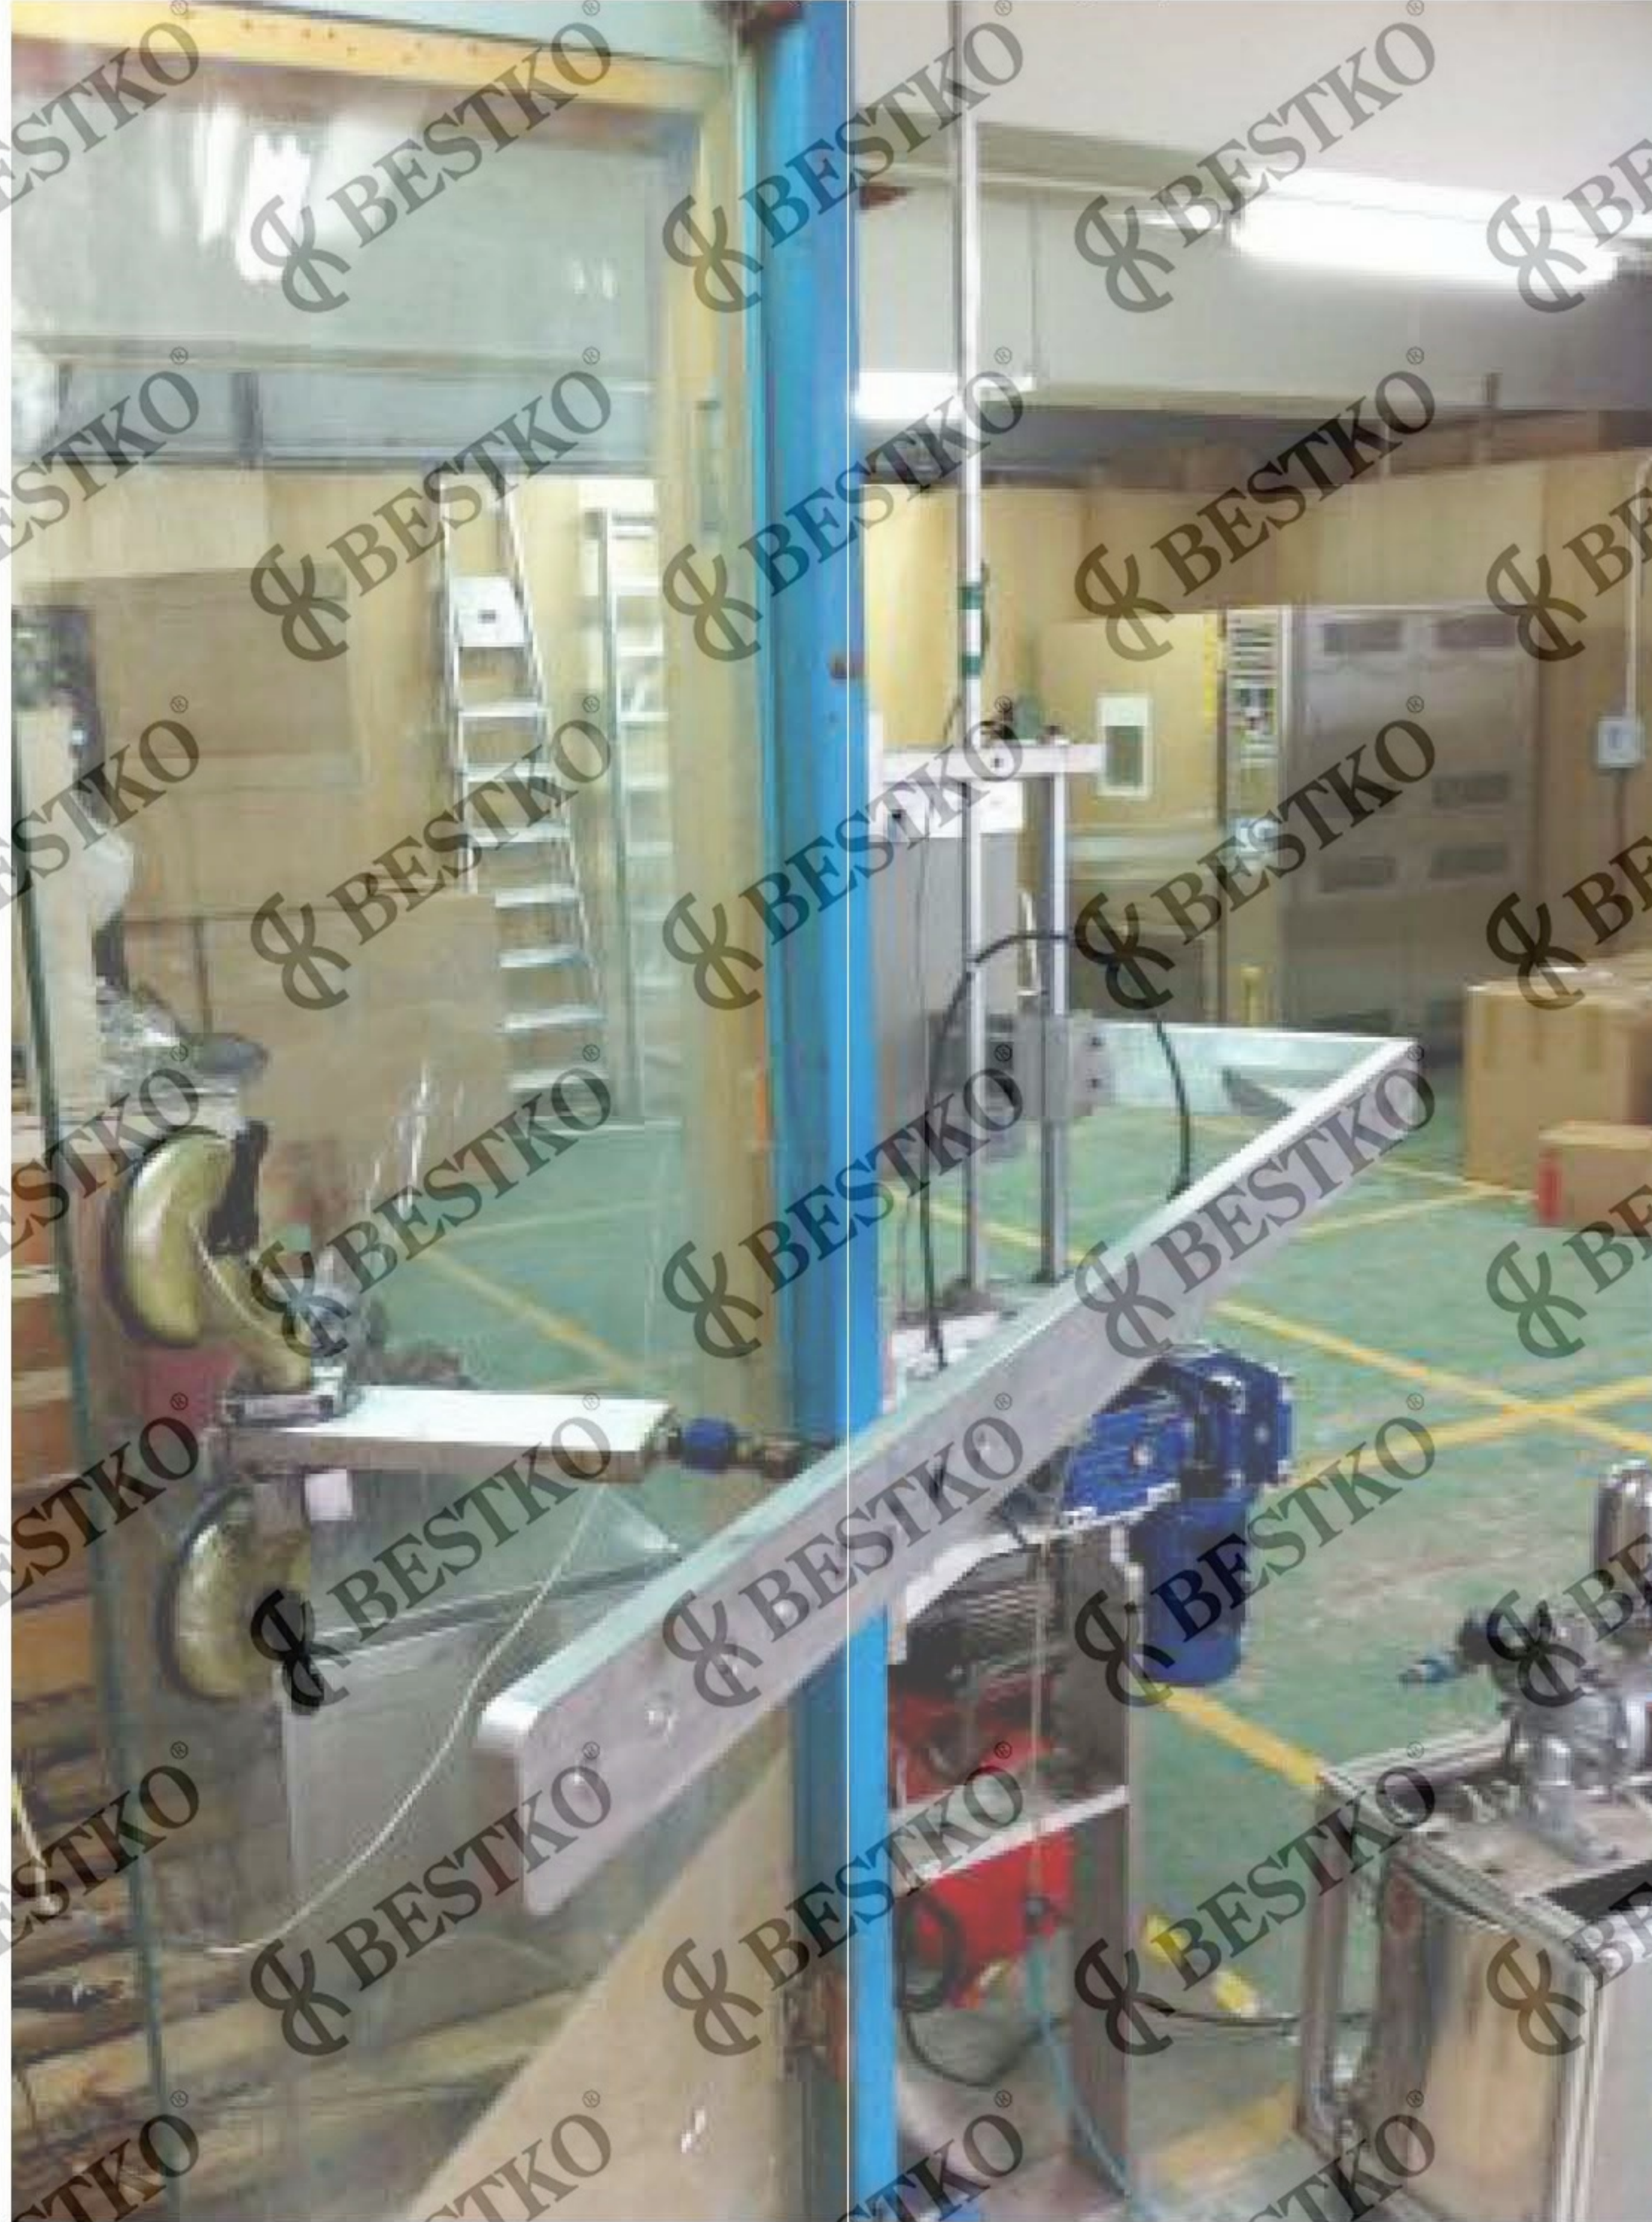
Test Set up Photograph:

1. The hinge with 800mm (width) x 2430mm (height) x 10mm (thickness) and 45kg total mass of tempered glass door were install in test frame that constructed of 6mm wall, 51mm x 102mm steel tubing.
2. The tempered glass door was swing from 0° (closed) to 90° (open) and back to 0°.
3. Inspect the hinges every specific cycle and record the closing time, closing moment and maximum open moment.

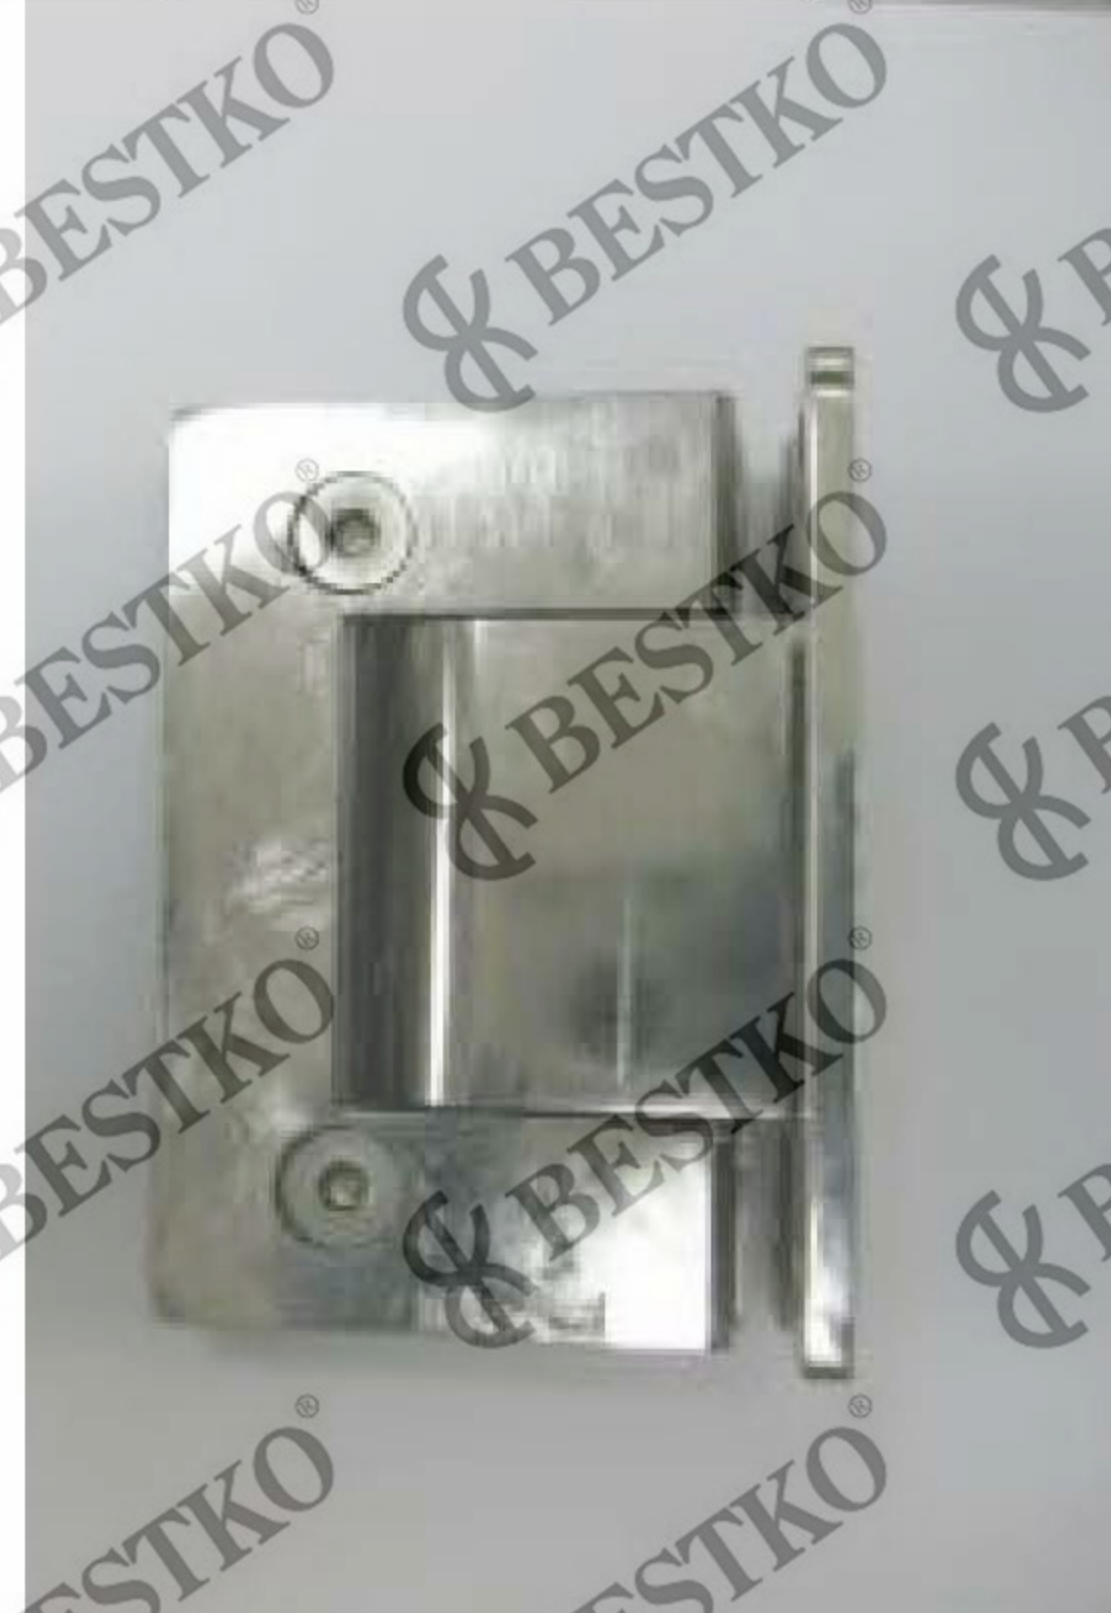
Sample: # TJ012-90° (After test)

Test Cycle	Test Item	Test direction		Submitted requirement	Comment
		Clockwise	Anti-clockwise		
Initial	Closing time(s)	5.6	5.7	Sample shall be no oil leakage and operated smoothly after 100,000 cycles plus 30% additional test cycles as customer's request.	Pass
	Closing moment(Nm)	6.0	5.6		
	Maximum open moment(Nm)	8.5			
	Observation	No oil leakage was observed and it could be operated smoothly.			
5,000	Closing time(s)	5.0	5.2		
	Closing moment(Nm)	4.3	4.4		
	Maximum open moment(Nm)	7.8			
	Observation	No oil leakage was observed and it could be operated smoothly.			
100,000	Closing time(s)	5.3	5.2		
	Closing moment(Nm)	4.2	4.3		
	Maximum open moment(Nm)	7.6			
	Observation	No oil leakage was observed and it could be operated smoothly.			
130,000	Observation	No oil leakage was observed and it could be operated smoothly.
