## STC Test Report

No: HT195865

: One (1) group of submitted sample said to be  
SHOWER HINGE  
Style No.: BK012-90°  
End Use: Bestko  
Country of Destination: Global

### Hinge Test

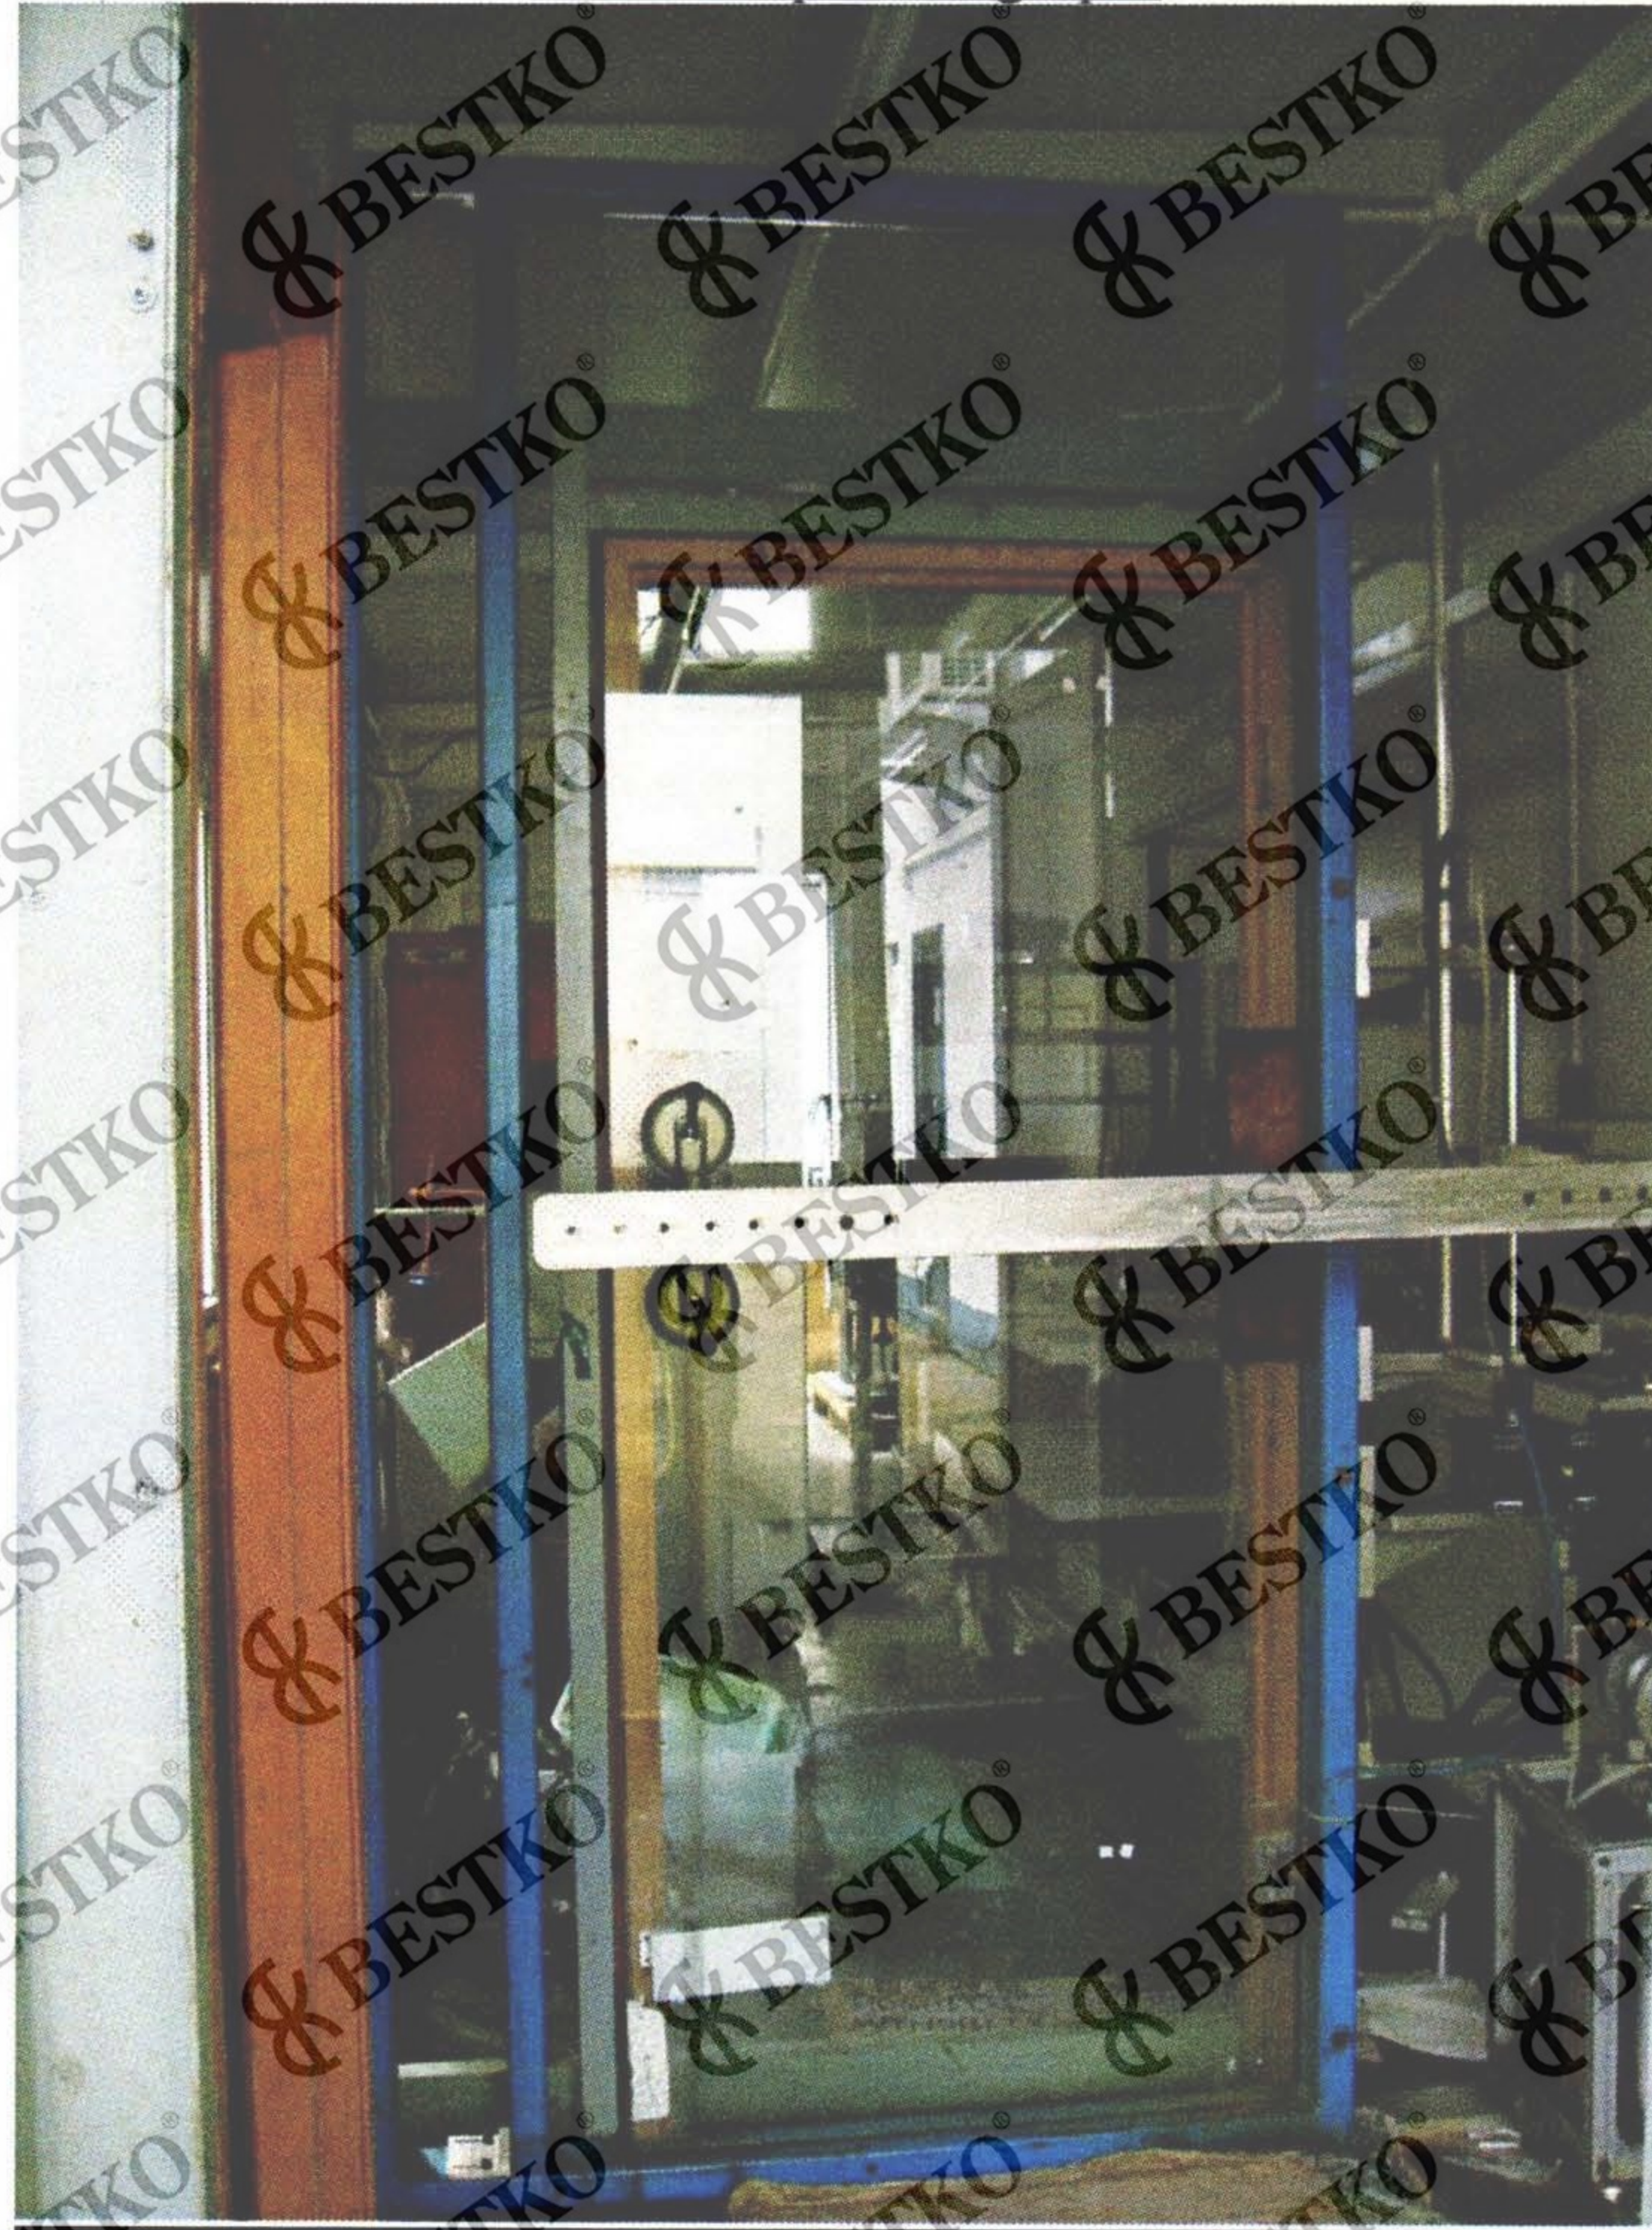
Test Set up Photograph:

1. The hinge with modified weight of 68kg tempered glass door were install in test frame that shall be constructed of 1/4 inch (6mm) wall, 2 inches (51mm) x 4 inches (102mm) steel tubing. The frame shall be no less than 36 inches (914 mm) wide and 96 inches (2438mm) in height. The corner shall be welded on the three exposed sides of a butt or mitered joint. Spacing between the vertical edges shall be plumbed to 1/8 inch (3mm) and spacing between the horizontal edges shall be plumbed to 3/16inch (5mm).

2. The tempered glass door was swing from 0° (closed) to 90° (open) and back to 0° every 10 seconds.
3. A mist of 80°F (+/- 3°F) tap water shall be directed onto one side of each hinge for 30 seconds every half-hour. Air temperature shall be maintained throughout the test at 72°F (+/- 3°F).

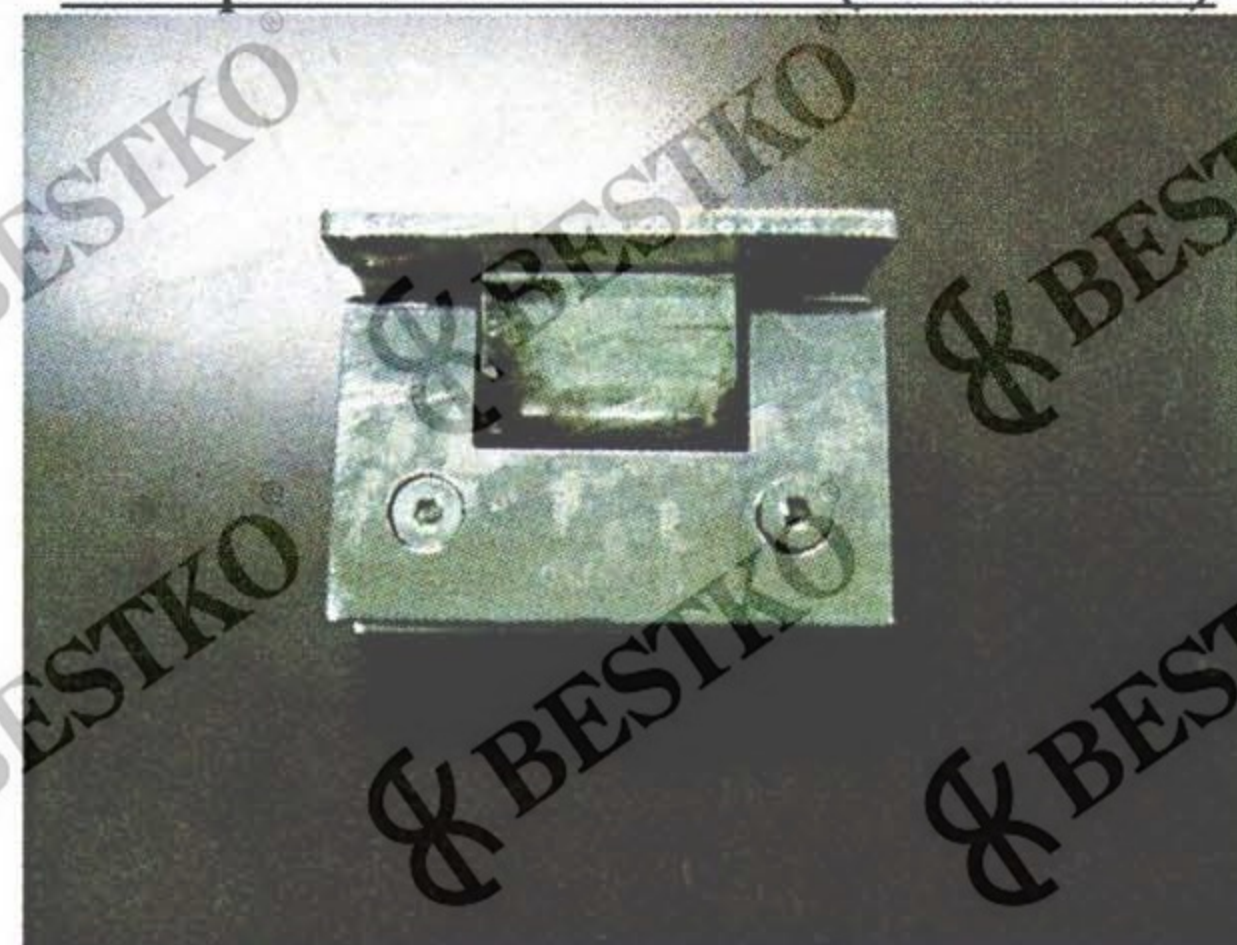
Sample: #BK012-90° (After test)

60,480	1) No noticeable degradation was observed on hinge. 2) Movement of vertical latch : 0mm		Pass
	69,120	1) No noticeable degradation was observed on hinge. 2) Movement of vertical latch : 0mm		Pass
	77,760	1) No noticeable degradation was observed on hinge. 2) Movement of vertical latch : 0mm		Pass
	80,000	1) No noticeable degradation was observed on hinge. 2) Movement of vertical latch : 0mm		Pass
