## STC Test Report

No: HT195867

: One (1) group of submitted sample said to be  
SHOWER HINGE  
Style No.: BK021-180°  
End Use: Bestko  
Country of Destination: Global

### Hinge Test

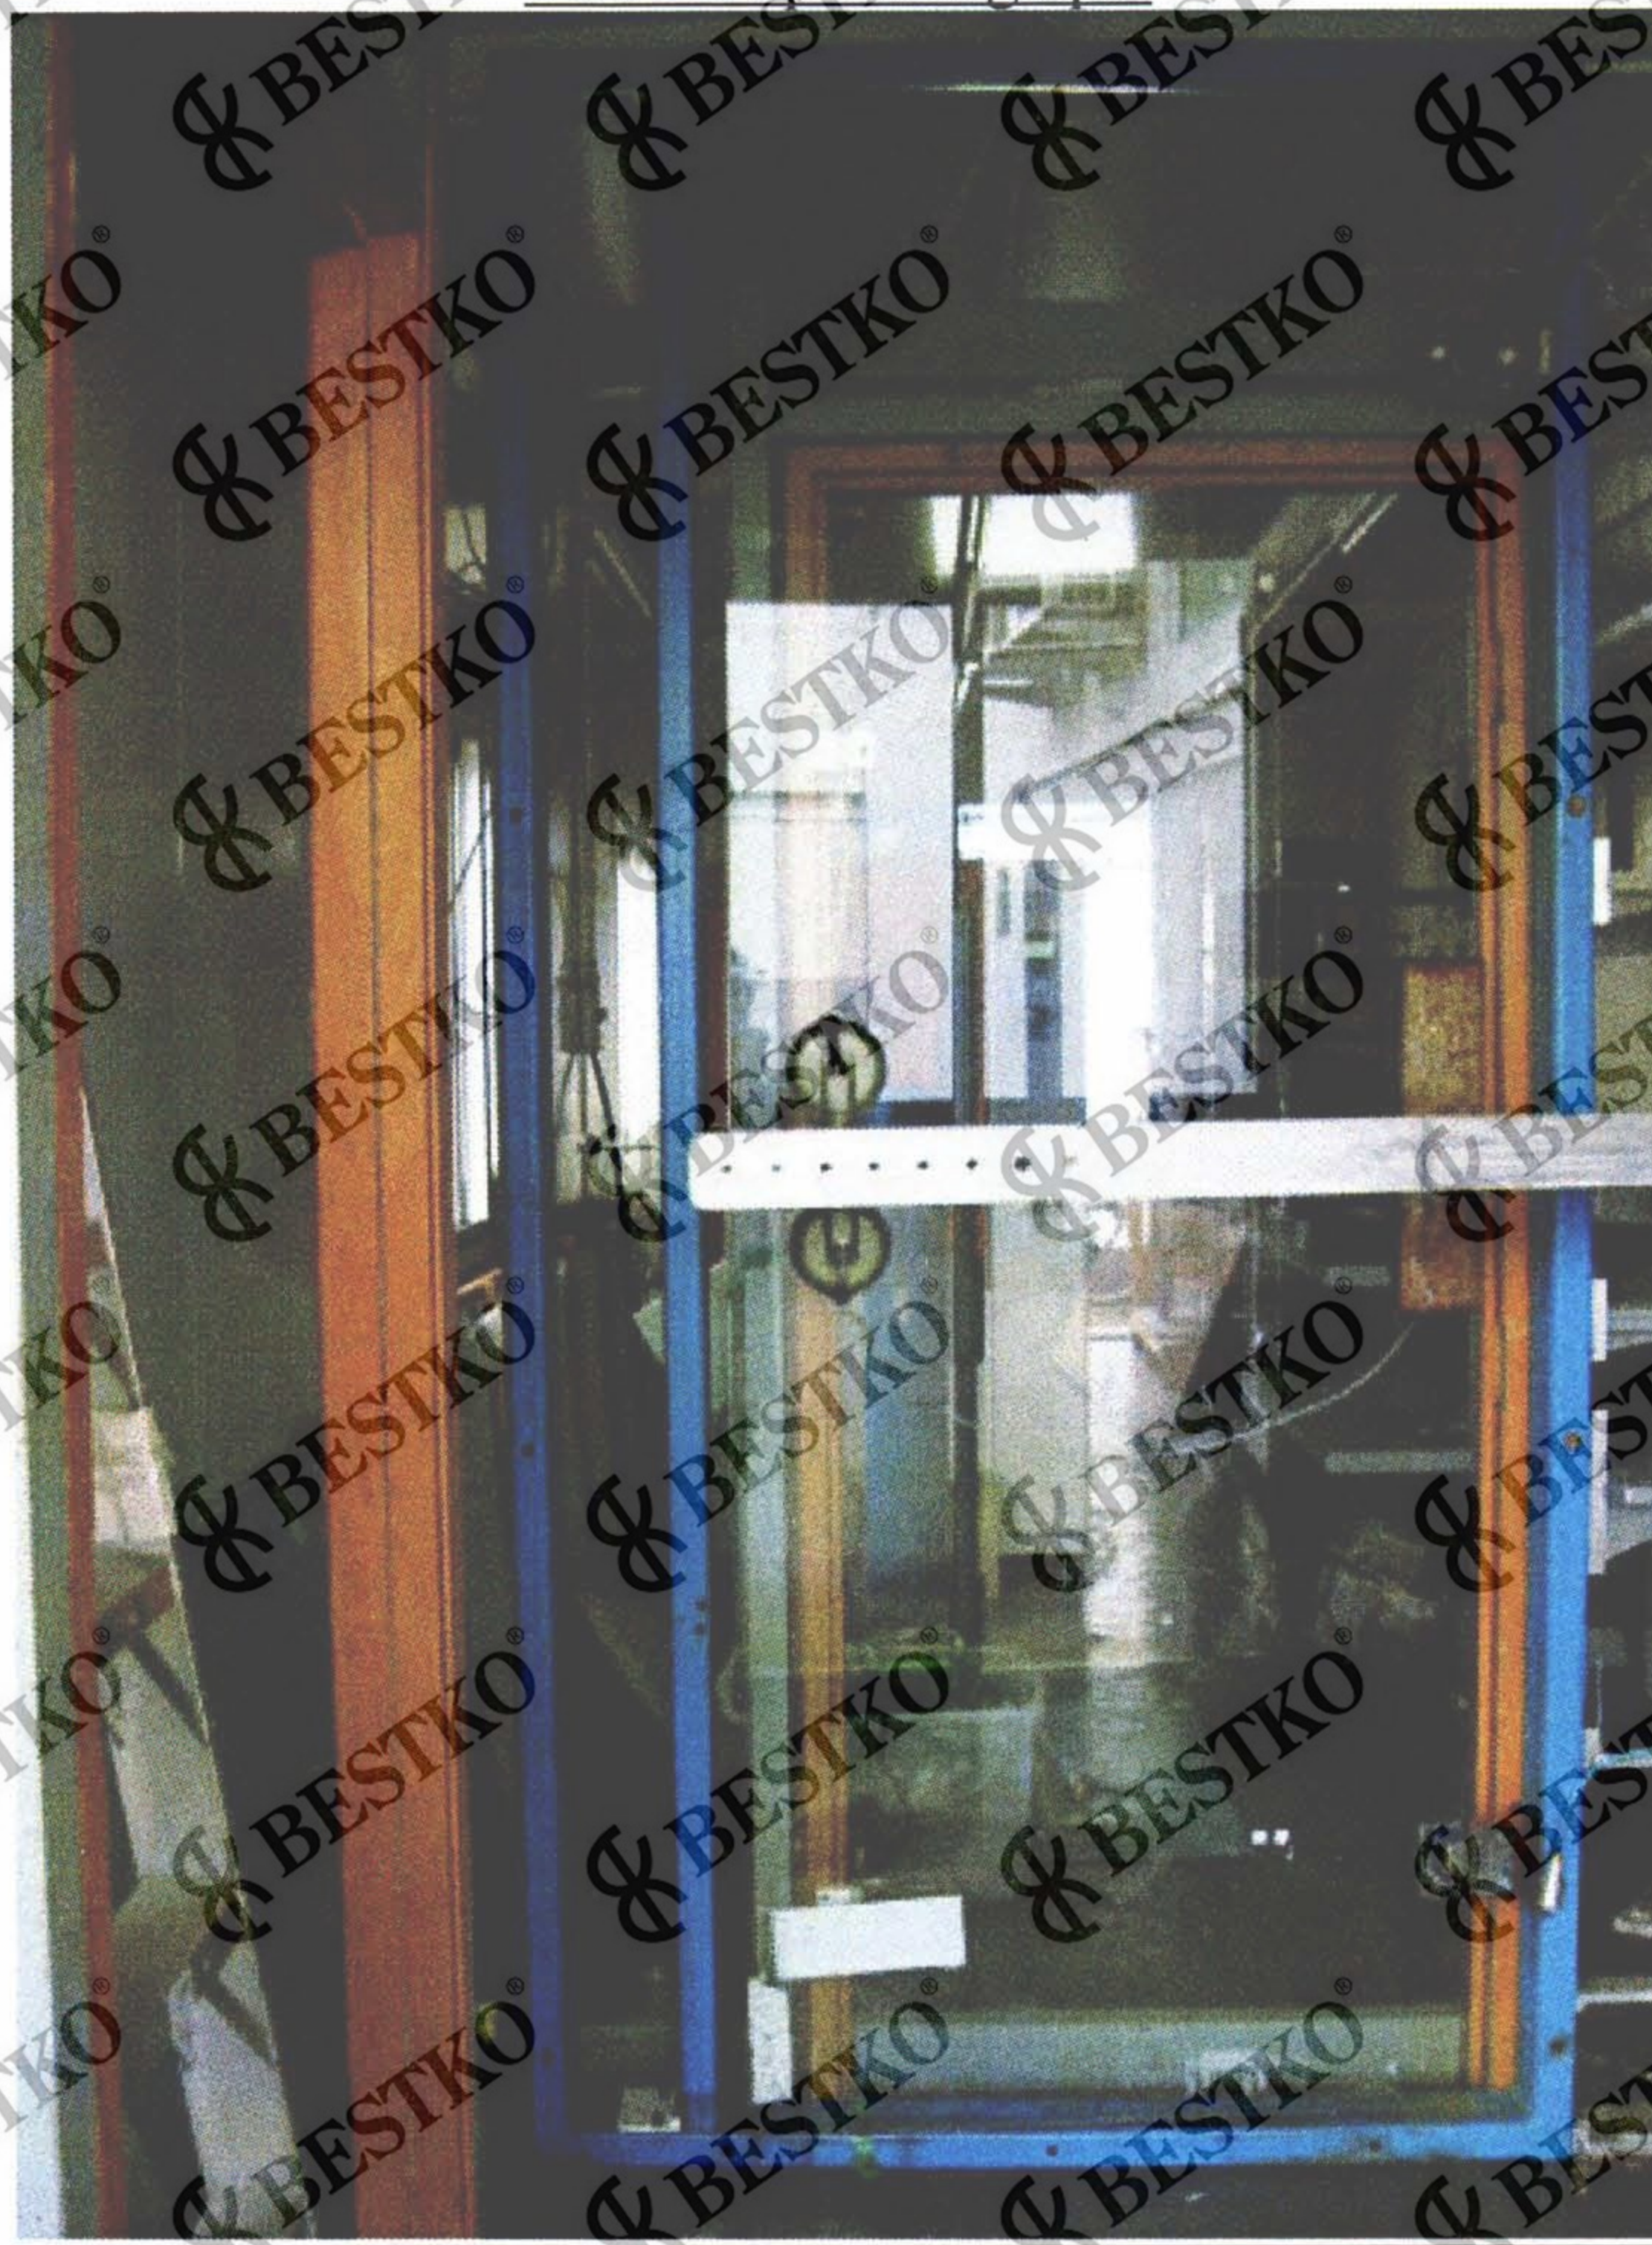
Test Set up Photograph:

1. The hinge with modified weight of 68kg tempered glass door were install in test frame that shall be constructed of 1/4 inch (6mm) wall, 2 inches (51mm) x 4 inches (102mm) steel tubing. The frame shall be no less than 36 inches (914 mm) wide and 96 inches (2438mm) in height. The corner shall be welded on the three exposed sides of a butt or mitered joint. Spacing between the vertical edges shall be plumbed to 1/8 inch (3mm) and spacing between the horizontal edges shall be plumbed to 3/16inch (5mm).

2. The tempered glass door was swing from 0° (closed) to 90° (open) and back to 0° every 10 seconds.
3. A mist of 80°F (+/- 3°F) tap water shall be directed onto one side of each hinge for 30 seconds every half-hour. Air temperature shall be maintained throughout the test at 72°F (+/- 3°F).

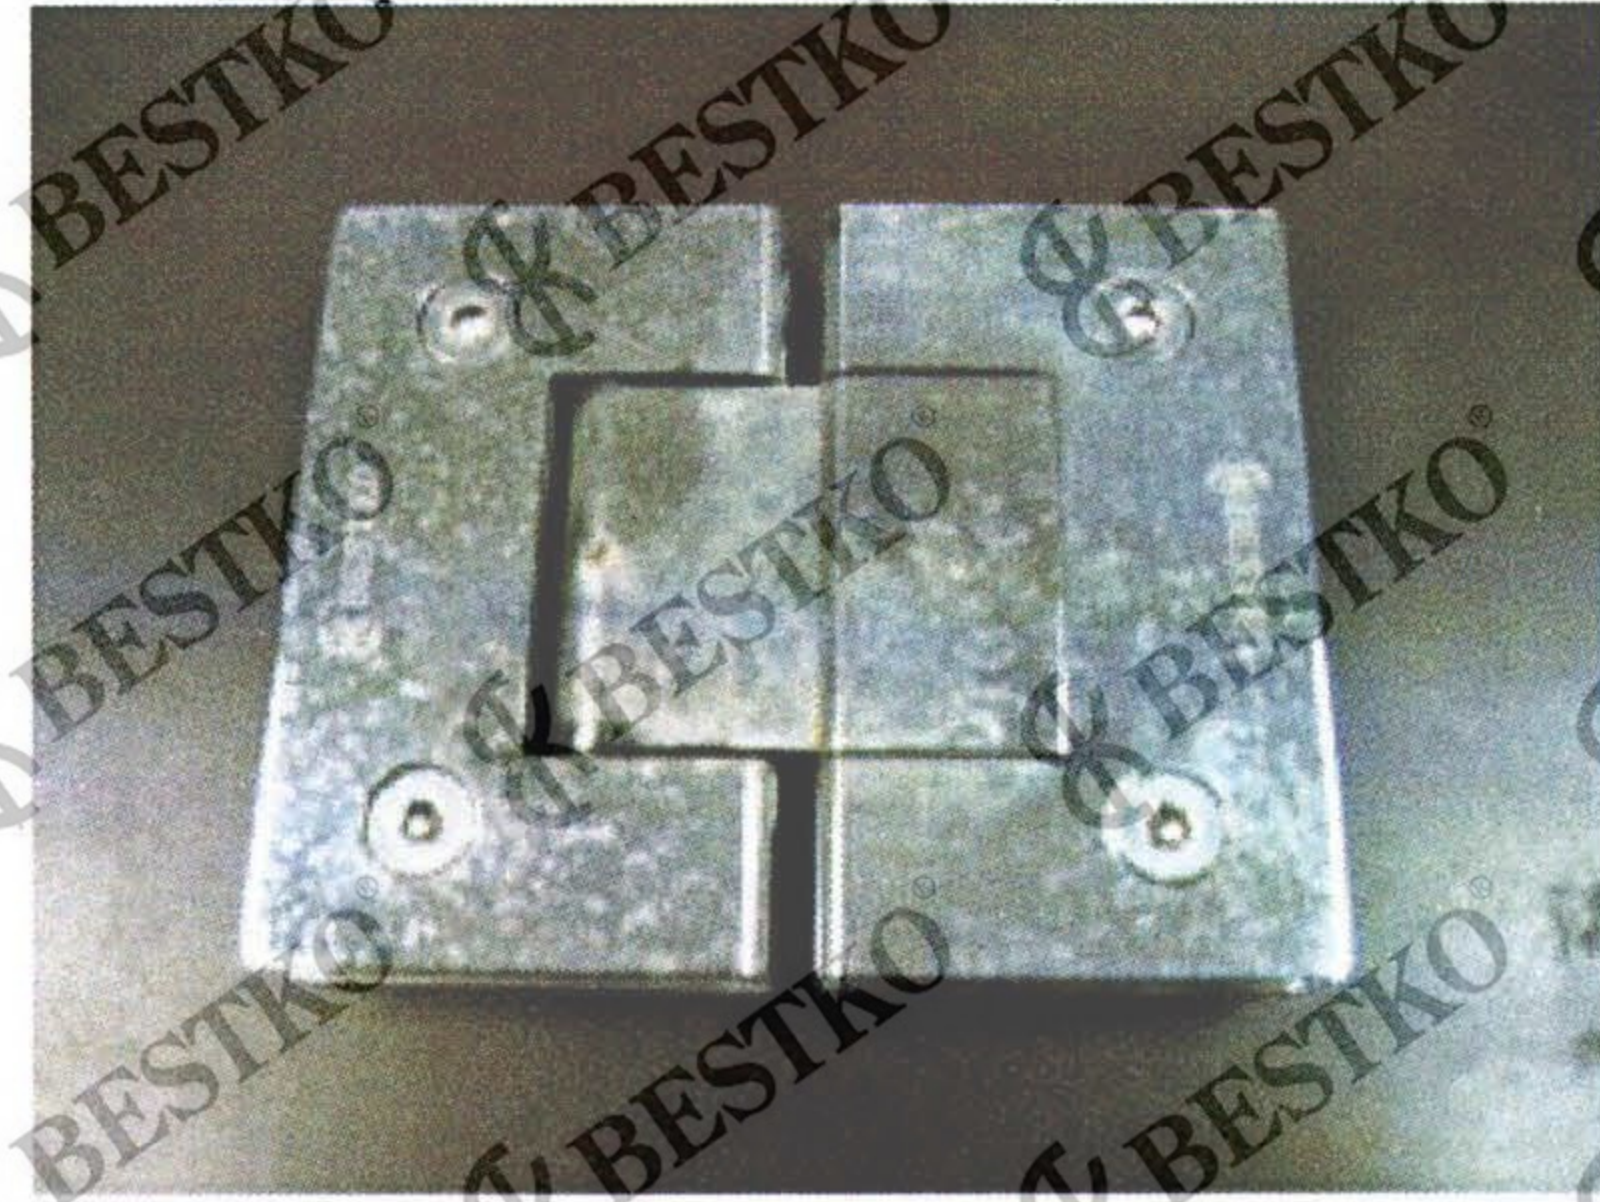
Sample: #BK021-180° (After test)

Sample	No. of cycle	Observation	Submitted requirement	Comment
#BK021-180°	8,640	1) No noticeable degradation was observed on hinge. 2) Movement of vertical latch : 0mm	1. If at any time during the test, noticeable degradation to the hinge becomes audible and/or visible through casual observation. 2. If slippage occurs, allowing movement of the vertical latch edge greater than 1/16 inch (2mm).	Pass
	17,280	1) No noticeable degradation was observed on hinge. 2) Movement of vertical latch : 0mm		Pass
	25,920	1) No noticeable degradation was observed on hinge. 2) Movement of vertical latch : 0mm		Pass
	34,560	1) No noticeable degradation was observed on hinge. 2) Movement of vertical latch : 0mm		Pass
	43,200	1) No noticeable degradation was observed on hinge. 2) Movement of vertical latch : 0mm		Pass
	51,840	1) No noticeable degradation was observed on hinge. 2) Movement of vertical latch : 0mm		Pass

60,480	1) No noticeable degradation was observed on hinge. 2) Movement of vertical latch : 0mm		Pass
	69,120	1) No noticeable degradation was observed on hinge. 2) Movement of vertical latch : 0mm		Pass
	77,760	1) No noticeable degradation was observed on hinge. 2) Movement of vertical latch : 0mm		Pass
	80,000	1) No noticeable degradation was observed on hinge. 2) Movement of vertical latch : 0mm		Pass
