STC Test Report

No: HT209490

: Two (2) pieces of submitted sample said to be
APPLAUSE SHOWER HINGE
Style No.: TJ012-90°
Country of Origin: China
Country of Destination: Worldwide

Corrosion tests in artificial atmospheres — Salt spray tests

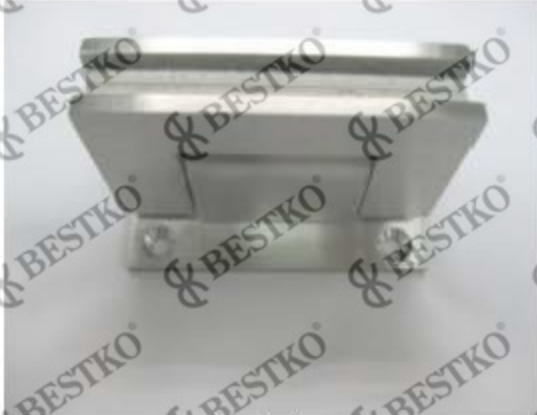
Front view

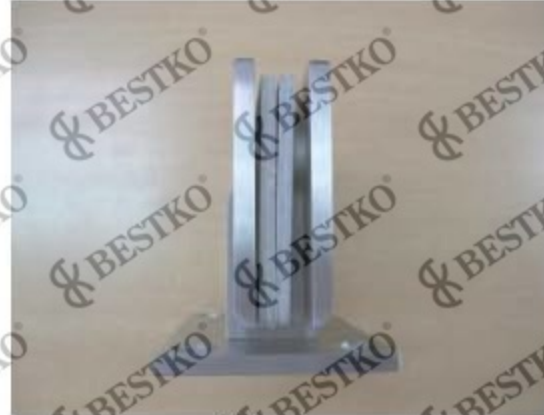
Side view
